24" Repair of Sea Water Header Leakage Composite Repair Case Study

24” Repair of Sea Water Header Leakage (Tee Joint)

Location: Abu Dhabi, U.A.E.

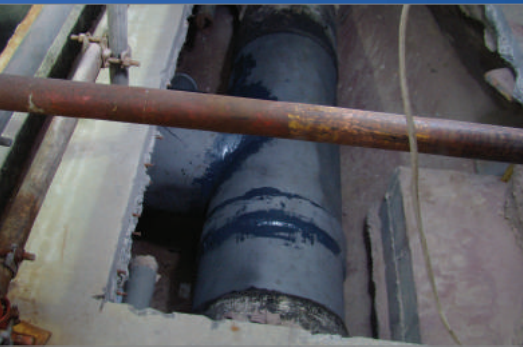
01

(Fig. I):- A 24” Tee joint sea water header had through wall metal loss and water leakage due to internal corrosion. The leak was arrested by welding a 10” pipe branching off at the 6 O’clock position.

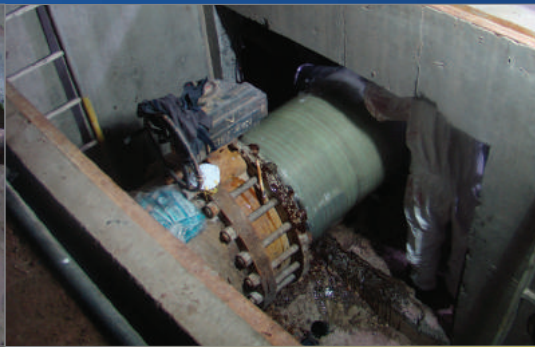
02

(Fig. II):- The repair methodology was requested to secure the full geometry from any further leakage due to internal corrosion. Clock Spring Contour composite wrapping technology was proposed by SKPS as a repair for the geometry.
