30" Clamp Clock Spring Contour Composite Wrapping Composite Repair Case Study

30" Clamp Clock Spring Contour composite wrapping Repair

Location: Abu Dhabi, U.A.E.

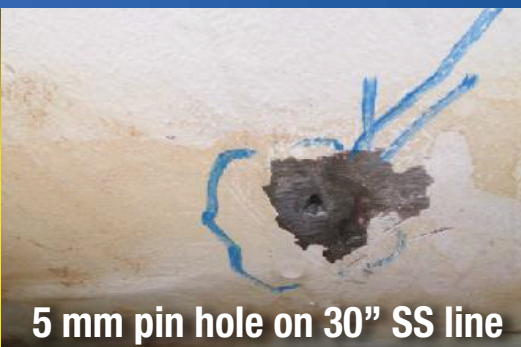
01

5 mm pin hole on 30" SS line

(Fig. I) .30" SS pipeline has pin hole at weld joint

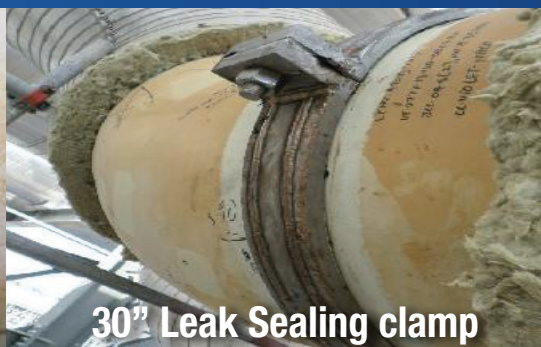
02

30" Leak Sealing clamp

(Fig. II) Leak sealing clamp was installed on the pipe to arrest the leak however due to pipe geometry and weld configuration, the leak was not sealed properly and seepage was observed on both side of the clamp.

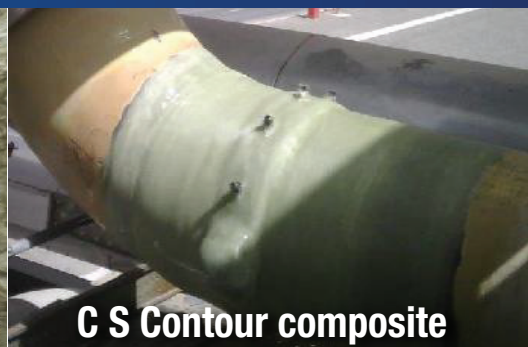
03

C S Contour composite

(Fig. III) Clock Spring Contour wet composite wrapping was the innovated repair solution to se- cure the leak and encapsulating it within the wrapping structure.

The application has been completed by using fast curing putty & Clock Spring Contour wet wrapping technology, the wrapping was extended 0.7 m on both side of the clamp to reinforce the defect terminals and to contain the existing leak.
