**Case Study**  
**48" Sea Water Header with Rivet in**  
**20 mm Hole using Clock Spring®**  
**Contour Composite Wrapping**

# 48” Sea Water Header with Rivet in 20 mm Hole using Clock Spring® Contour Composite Wrapping

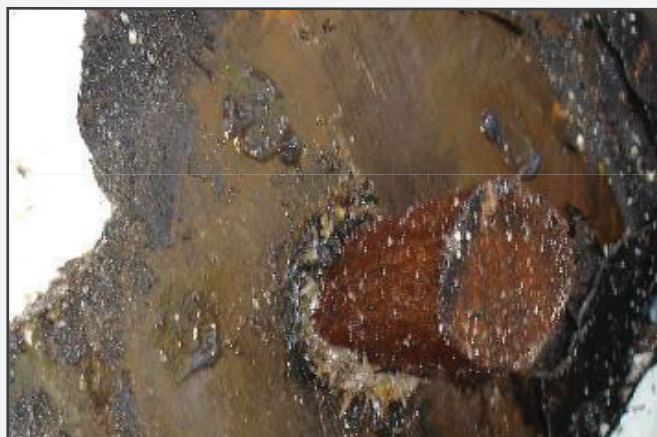
## 1 Defect area

48” Sea water header had a severe leak that required to be sealed using a wooden rivet. Shutting down the line was not an option, the “Clock Spring Contour” was the nominated method of repair to hold the “Leak” for at least another 2 years.

Operating Temperature	: Ambient
Operating Pressure	: 4 barg
Defect Type	: Internal Corrosion
Size	: 48 inch
Material	: API5L
Defect Analysis	: Wall metal loss 20mm dia hole leak
Orientation of leak	: 5 O'clock
Lifetime	: 5Years

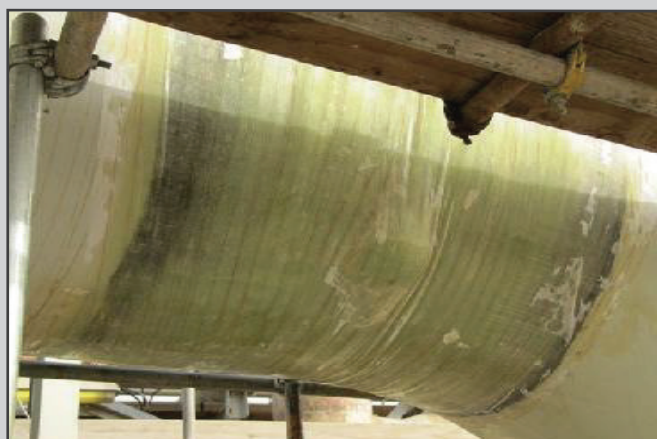
## 3 Clock Spring® Contour Application

The rivet was not removed and the “bulging” on the center can be clearly seen at the 5 O’clock position.
