# 8" External Corrosion using Clock Spring® and Contour

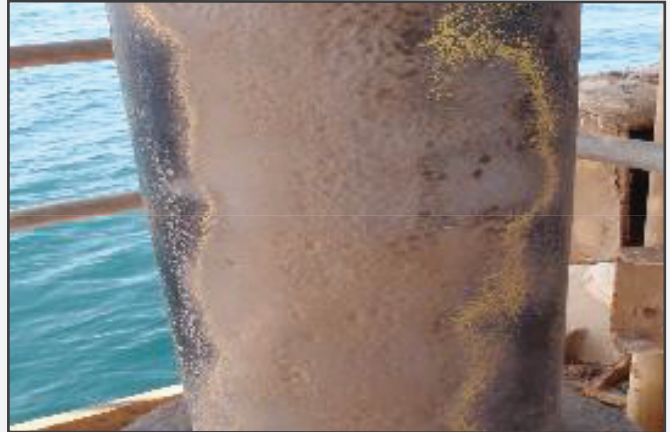
## 1 Defect area

After completing a routine offshore IPS run, an 8" riser exhibited severe external corrosion spanning across the total length of the riser with up to %68 metal loss on a stretch of 13,000 mm from the splash zone up to the top side of the well head platform. Highly corroded section of the riser.

Operating Pressure	: 1,000 psi
Operating Temp	: 60° Celsius
Defect Type	: External Corrosion
Size	: 8"
Material	: API 5L-X52
Defect Analysis	: External metal loss scattered across the riser
