**16" Fire Water Pipeline with Multiple  
Pin Holes Repair using Clock Spring®  
Contour composite wrapping**

# 16” Fire Water Pipeline with Multiple Pin Holes Repair using Clock Spring® Contour composite wrapping

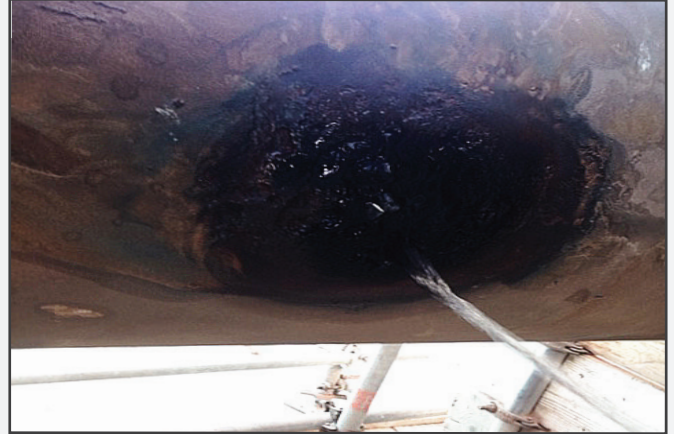
## 1 Defect area

16” Fire Water Pipeline had several pin holes due to a severe external corrosion defect. The holes size varied from 5mm up to 35mm. The pipe had been put out of service due to the leak while the SKPS team had immediately mobilized to location and provided the remedial action.
