**FRP Pipe Leak Repair using
Clock Spring® Contour (1500mm dia)**

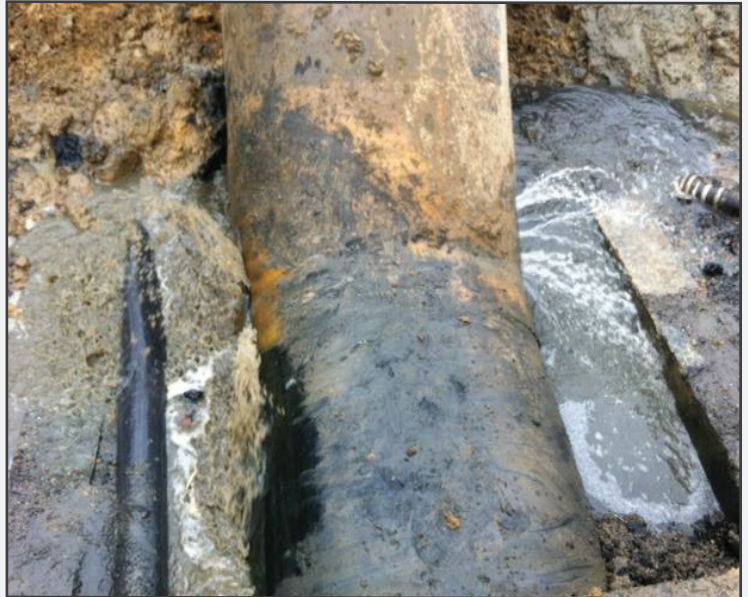
1 Repair Area

Ground movement had caused a crack at a miter bend location which with applied stresses had caused a failure in the body of the main pipe. Leak found and line drained.
