Case Study
4", 6" and 8" Riser Repairs Offshore
Viscotag® (Viscous Elastic Coating)

4", 6" and 8" Riser Repairs Offshore Viscotaq® (Viscous Elastic Coating)

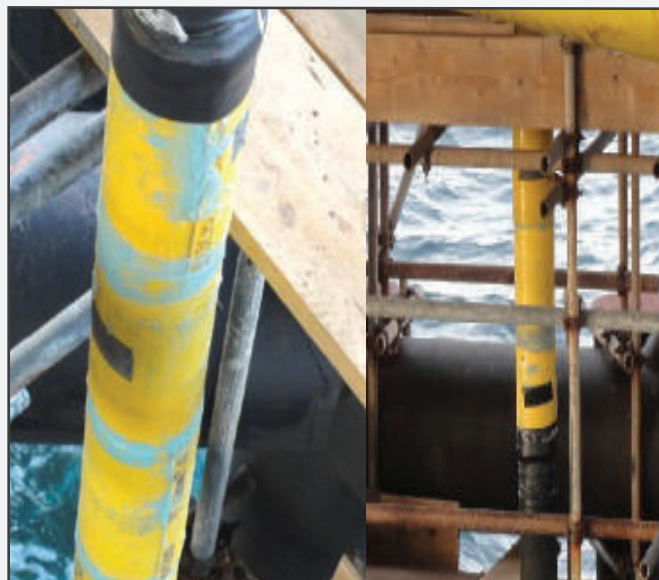
1 Clock Spring Application

An offshore oil producing platform had external corrosion on the length of its risers. The risers were repaired using Clock spring and coated with a suitable coating in addition to protecting the flanges in between.

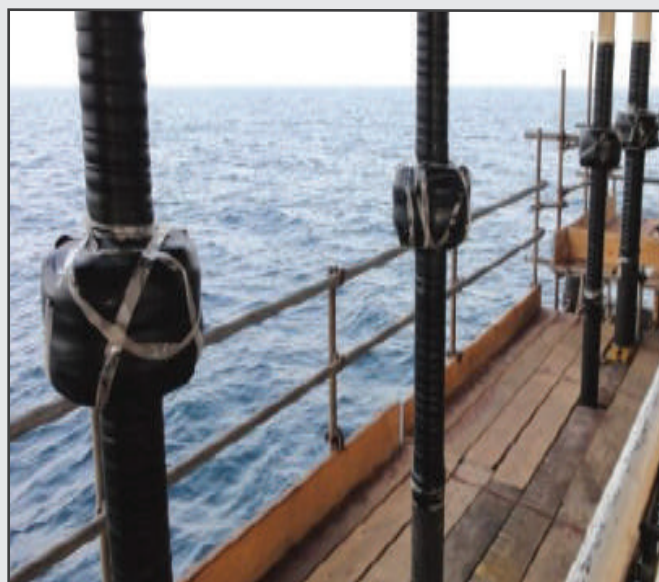
2 Viscotaq Application

The completed repair after the Clock Spring Installation and application of the Viscotaq. Two (2) Certified Clock Spring Engineers from SKPS and 5 days to complete a scope of 4x, "4 7x6" and 6x8" risers Also attached additional photographs of this application.
