Case Study
36" Pinhole Leak Composite Repair
on Shut Down Valve

36” Pinhole Leak Composite Repair on Shut Down Valve

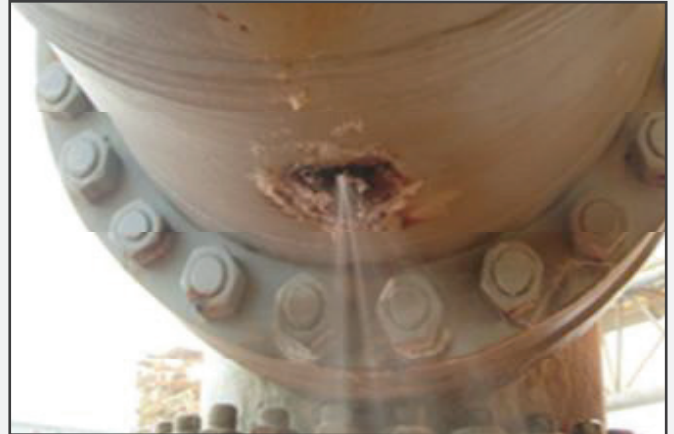
1 Defect area

36” Shut Down Valve with internal corrosion accumulated a “Pinhole leak”. It was previously sealed using a rubber lined clamp that eventually failed. A repair solution was engineered to arrest the leak and seal the valve from any further leaking.
