Case Study
14" Structural Reinforcement
using Clock Spring® Extended
Snap Wrap

14” Structural Reinforcement using Clock Spring® Extended Snap Wrap

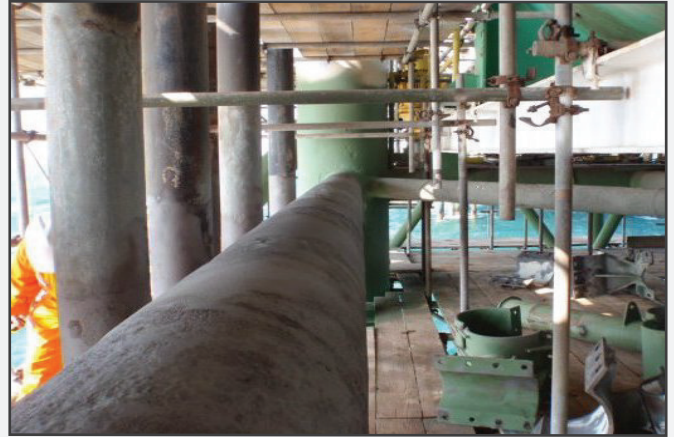
1 Defect area

An offshore 14” structural beam supporting 4x8” risers was found to have high corrosion spread across the whole structure and on all orientations. This required immediate structural reinforcement either by welding or “Extended Clock Spring Snap Wrap”. Since welding was a hazard to the operation, a composite solution was engineered. All 4 clamps were removed and the surface was prepared to SA 2½.

Actual Wall Thickness : 19.05mm

Minimum Remaining Wall Thickness : 9.1mm

Defect Type : External Corrosion

Defect Analysis : Maximum Wall loss of 58%
Average Wall loss of 28%
