Clamped 16” SDV Sealed with Clock Spring Contour Composite Repair

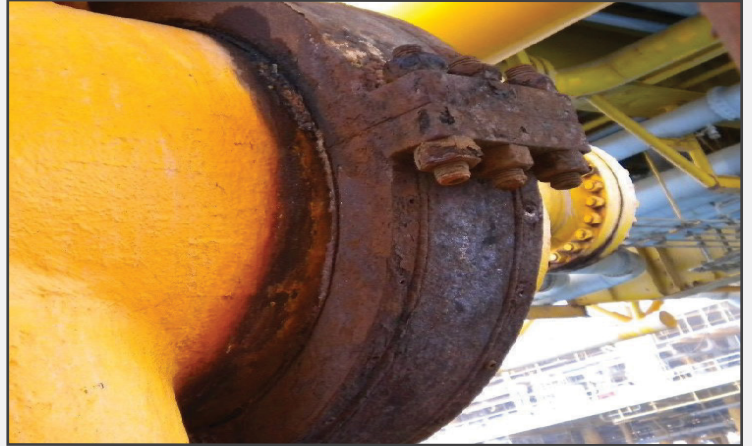
1 Repair Area

16” Shut Down Valve suffering a through wall defect was sealed with a leak sealing clamp. Clamped area failed and required an immediate solution to avoid oil from seeping through.

A composite repair was engineered to cover all 360° of the clamp to encapsulate the SDV.

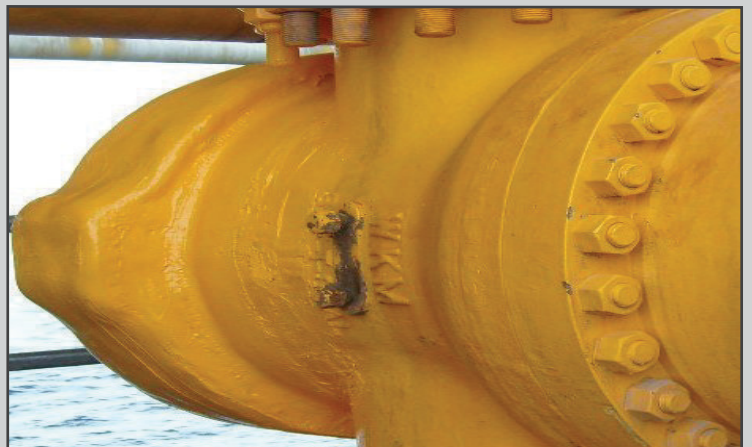
3 Final repair

Painted area.
