Case Study
**60" Main Water Transmission
Line Reinforced by Clock Spring®**

60” Main Water Transmission Line Reinforced by Clock Spring®

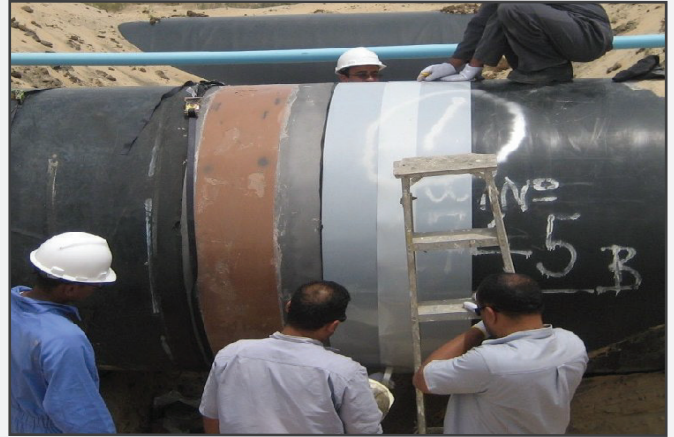
1 Defect area

After an intelligent pigging campaign, several locations exhibited external corrosion/pitting across several areas of the weld joints that required immediate attention to ensure the safe operation of the pipeline. As exhibited , a single wrap mould was used to cover the areas with filler to ensure the defects were fully covered and smooth, allowing the Clock Spring to wrap around the pipe. This exercise required approximately 1 hour to complete.

Operating Temperature	: 120° F
Operating Pressure	: 810PSI
Defect Type	: External Corrosion & Pitting
Size	: 60” inch main waterline
Defect Analysis	: Wall thinning and metal loss up to 55%
