Case Study
30" Clamp Repair using Clock Spring®
Contour Composite Wrapping

30" Clamp Repair using Clock Spring® Contour Composite Wrapping

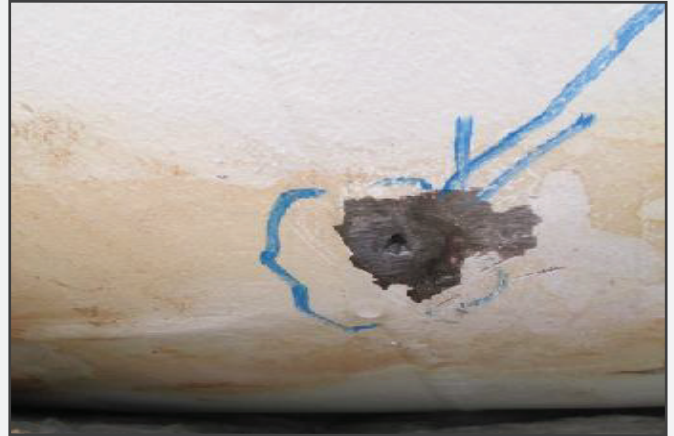
1 Defect area

30" SS pipeline has pin hole at weld joint

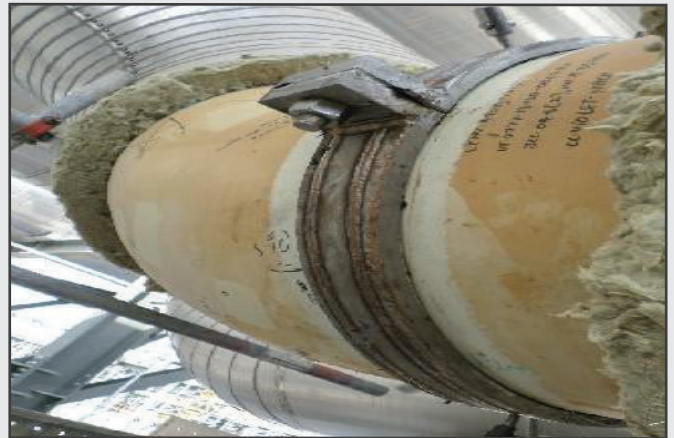
2 Leak Sealing Clamp

Leak sealing clamp was installed on the pipe to arrest the leak however due to pipe geometry and weld configuration, the leak was not sealed properly and seepage was observed on both sides of the clamp.
