Case Study
High Temperature 30" Gas Pipeline
with Sever External Metal Loss
Viscotag® (Viscous Elastic Coating)

High Temperature 30” Gas Pipeline with Sever External Metal Loss Viscotaq® (Viscous Elastic Coating)

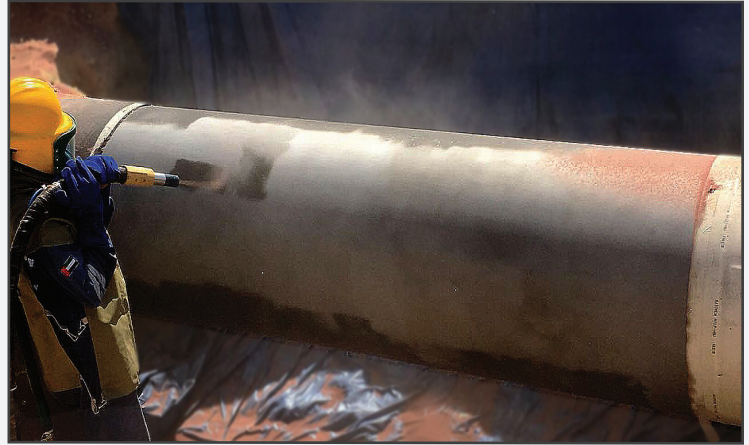
1 Surface Preparation

30” Gas Pipeline suffered severe external corrosion defects due to coating failure. Existing coating removed and the pipe was surfaced prepared to SA 2 ½.
