2" x 30" Nozzle Repair Clock Spring® Contour Composite Wrapping

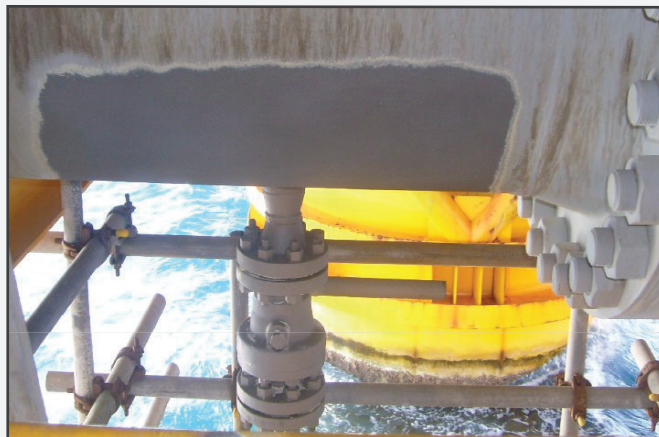
1 Defect area

The nozzle/main header after the surface preparation .SKPS designed a Clock Spring Contour composite repair according to ISO 24817 and attended to the repair in less then 48 hours from initial contact.

Operating Temperature	: 120° F
Operating Pressure	: 80PSI
Defect Type	: Internal Corrosion
Size	: 2 inch weldolet
Design Pressure	: 250PSI
Defect Analysis	: Wall thinning with metal loss up to 50 %
Lifetime	: 5Years

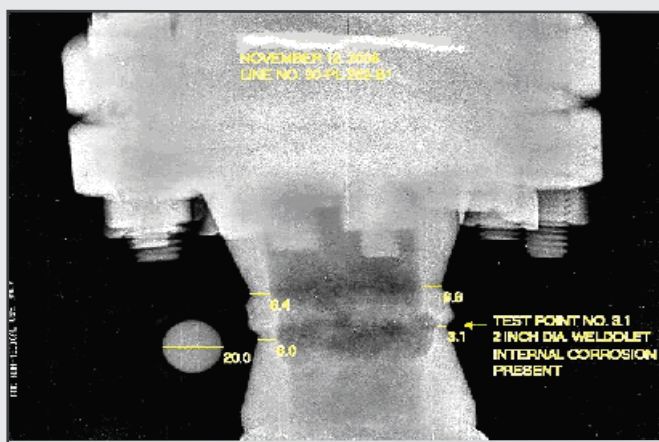
2 Radiograph image of the nozzle.

During a routine inspection campaign for an offshore oil producing company, a 2" nozzle (from a 36" main header) with internal corrosion was detected and needed immediate attention.

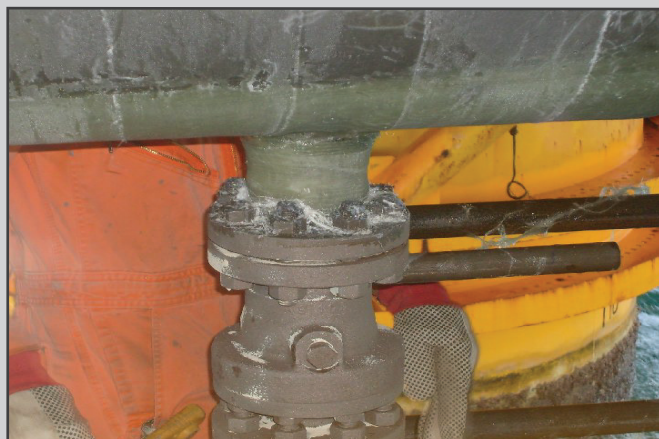
3 Clock Spring® Contour Application

The Final repair.
