**2" x 30" Nozzle Repair Clock Spring®
Contour Composite Wrapping**

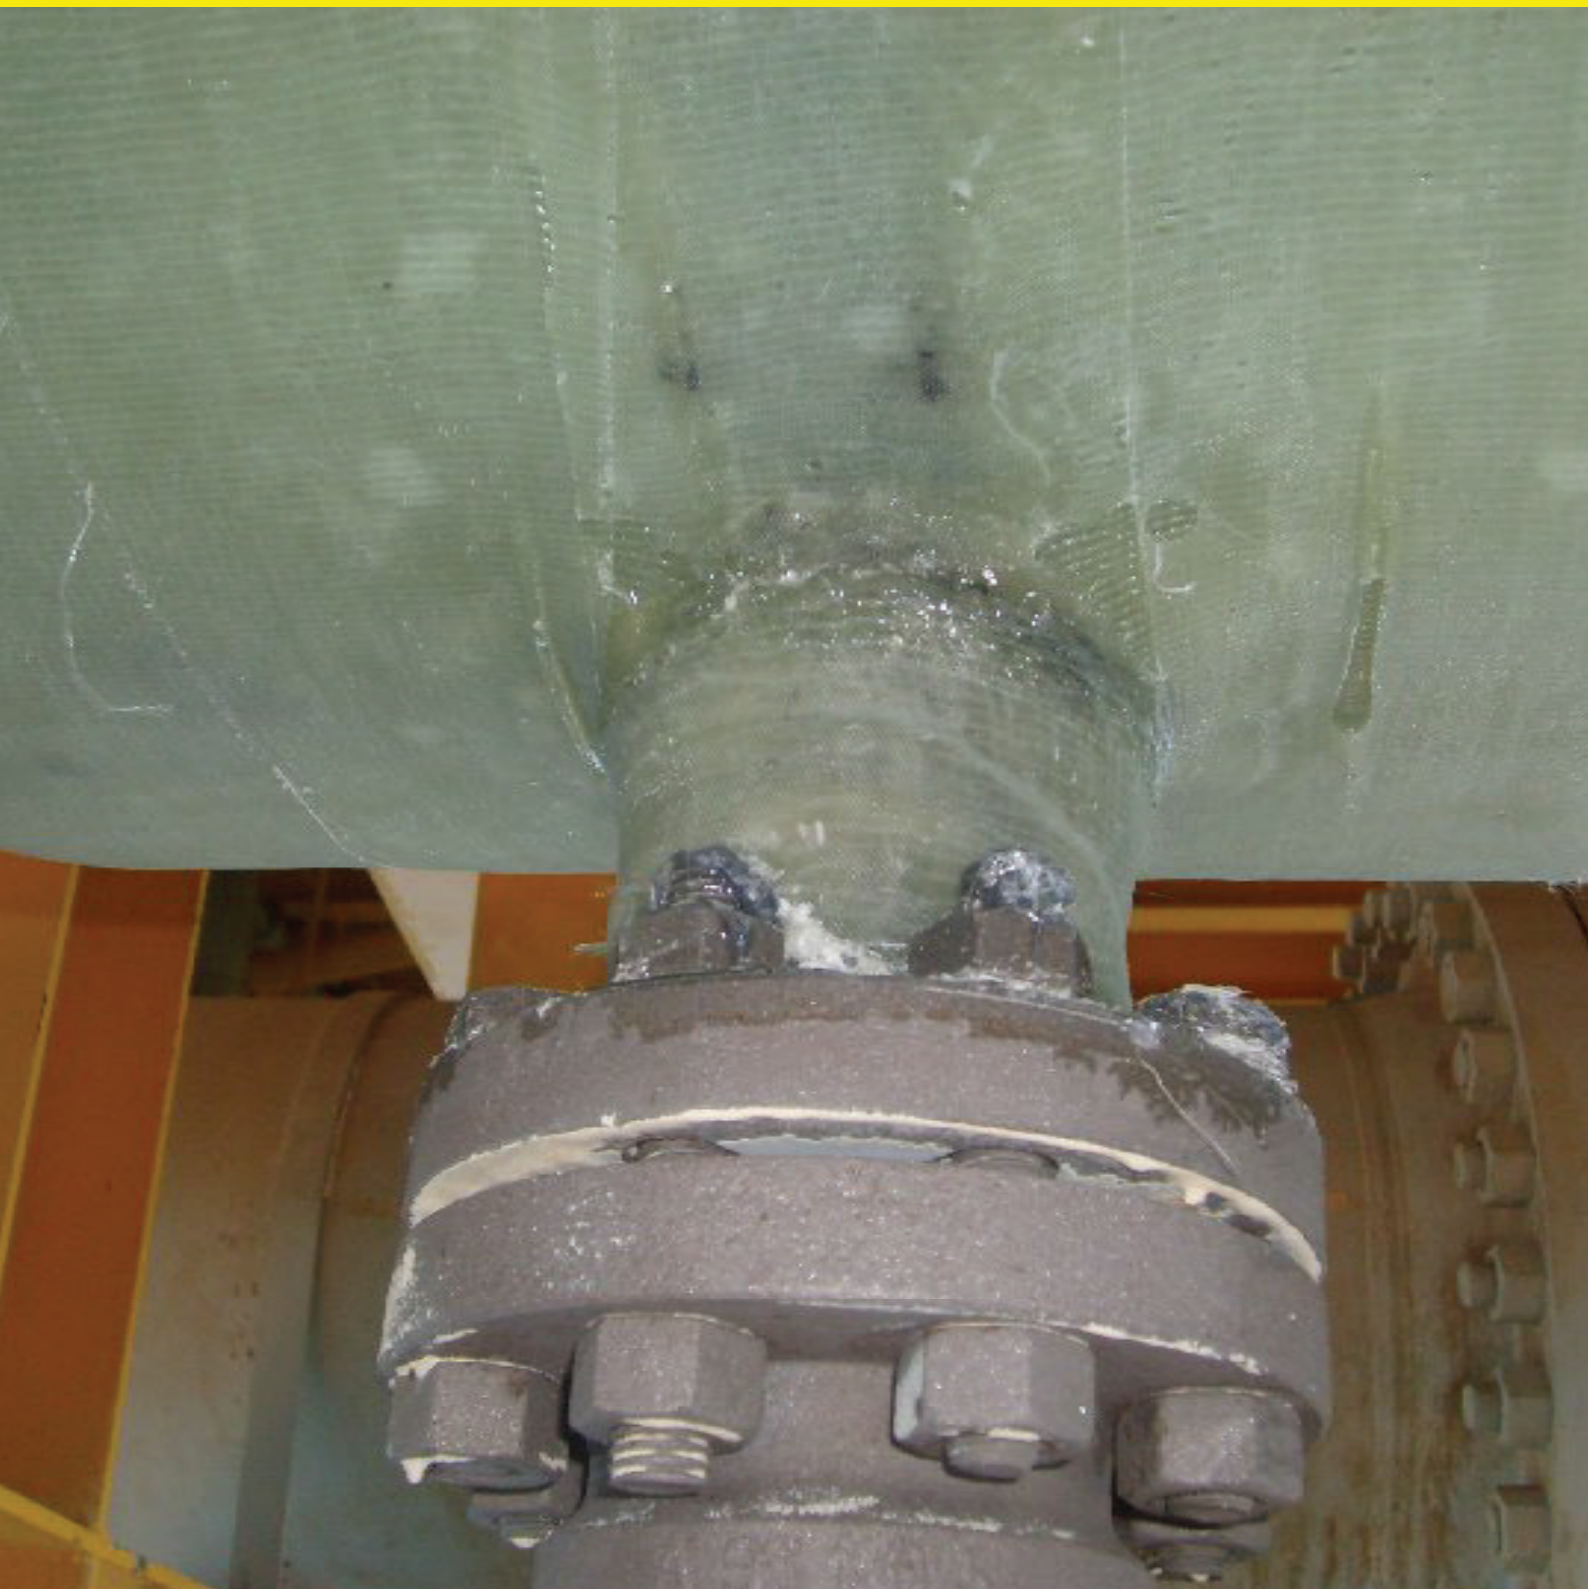
1 Defect area

The nozzle/main header after the surface preparation .SKPS designed a Clock Spring Contour composite repair according to ISO 24817 and attended to the repair in less then 48 hours from initial contact.

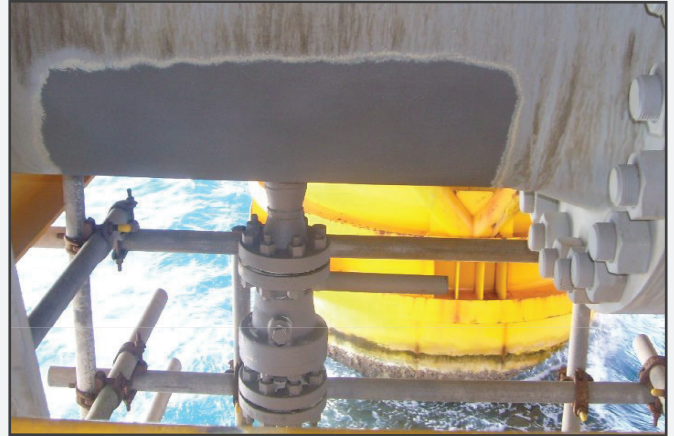
2 Radiograph image of the nozzle.

During a routine inspection campaign for an offshore oil producing company, a 2" nozzle (from a 36" main header) with internal corrosion was detected and needed immediate attention.

Operating Temperature	: 120° F
Operating Pressure	: 80PSI
Defect Type	: Internal Corrosion
Size	: 2 inch weldolet
Design Pressure	: 250PSI
Defect Analysis	: Wall thinning with metal loss up to 50 %
Lifetime	: 5Years
