Case Study
24” Repair of Sea Water Header
(Leaking Tee Joint) using Clock Spring®
Contour Composite Wrapping

24” Repair of Sea Water Header (Leaking Tee Joint) using Clock Spring® Contour Composite Wrapping

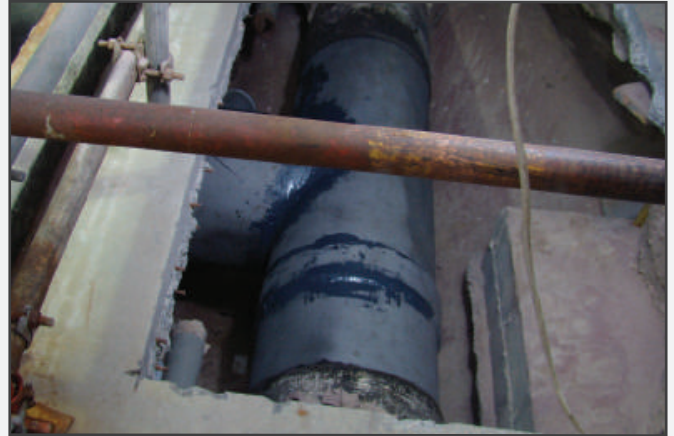
1 Defect area

A 24” Tee joint sea water header had through wall metal loss and water was Leaking due to internal corrosion. The leak was arrested by welding a 10” pipe branching off at the 6 O'clock position.
