**20" Leaking Header Line Repair  
using Clock Spring® Contour Wrap**

# 20" Leaking Header Line Repair using Clock Spring® Contour Wrap

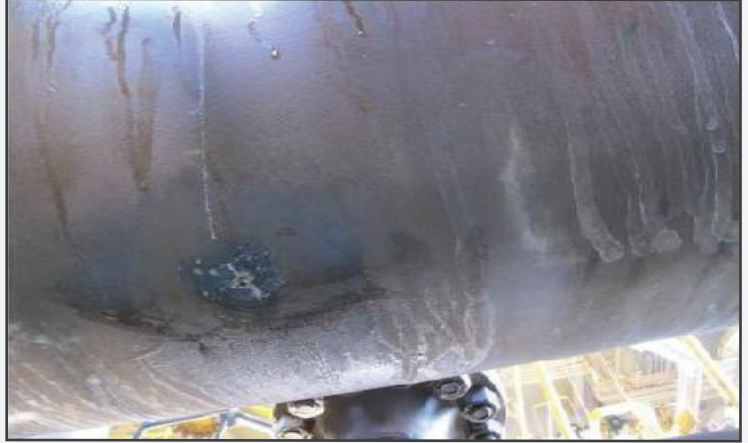
## 1 Repair Area

A 20" header line exhibited a pin hole leak at the 6 'O'clock position due to internal corrosion.

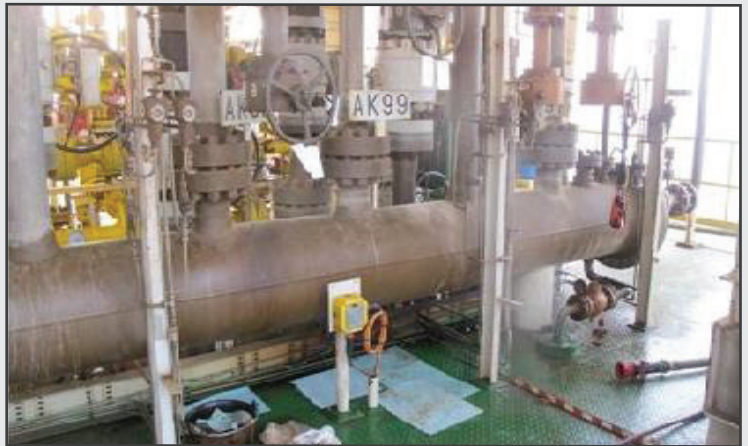
## 2 Surface Preparation

This was a main header line operating @20 bar. The requirement was an immediate reinforcement for a minimum period of 2 years.
