# 8" External Corrosion using Clock Spring® Composite Repair

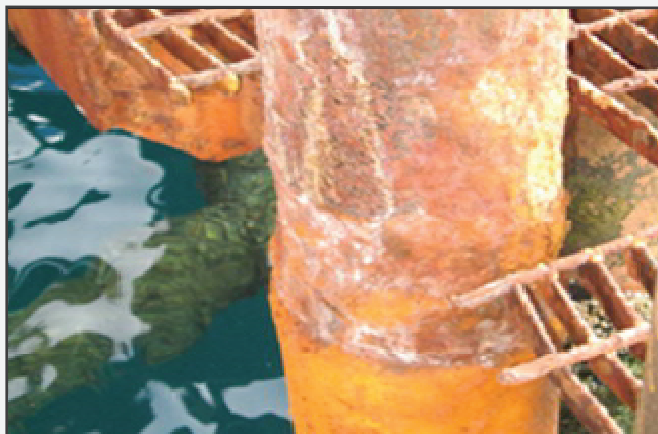
## 1 Defect area

An external corrosion was found at several locations at an Offshore production platform oil producer operator on 8" riser due to neoprene coating damage. External corrosion found at several locations on an 8" Offshore riser due to neoprene coating damage.

Operating Pressure	: 2233 psi
Operating Temp	: 70° Celsius
Defect Type	: External Corrosion
Size	: 8"
Material	: API 5L-X 60
Defect Analysis	: External corrosion caused by Neoprene coating damage.
