**Case Study**  
**18" Propane Liquid export  
Pipeline with severe  
external pitting and pin holes**

# 18” Propane Liquid export Pipeline with severe external pitting and pin holes

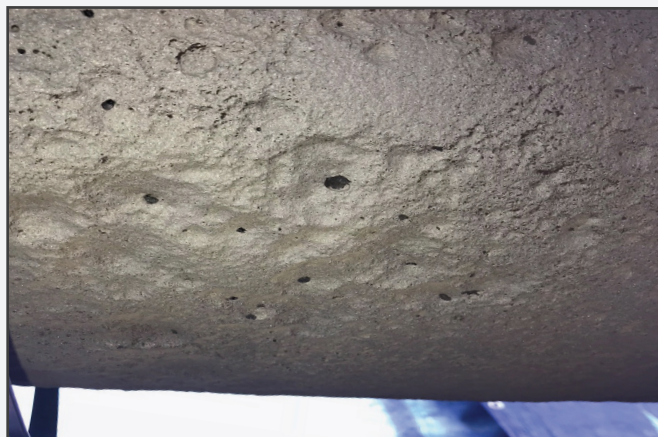
## 1 Defect area

18” Propane Pipeline had several pin holes due to severe external corrosion defects. The holes size varied from 3 mm up to 8 mm. The pipe had been put out of service, SKPS team immediately mobilized to location and provided the remedial action.
