18" Trunk Line Clock Spring® Composite Wrapping

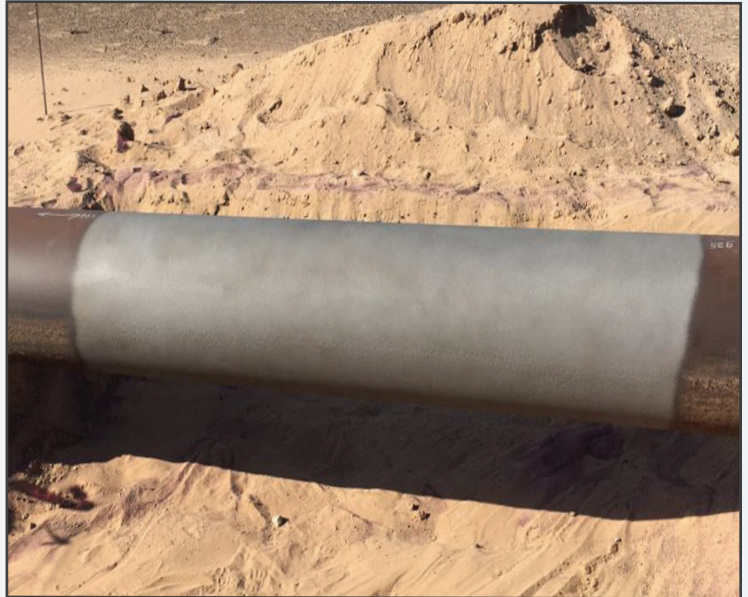
1 Surface Preparation

Inspection on 18" trunk line has highlighted external corrosion on 2 locations.

Surface preparation was done in SA 2 ½ by blasting. Steel putty has been applied on the wall thinning and uneven surfaces prior to the Clock Spring® composite application.

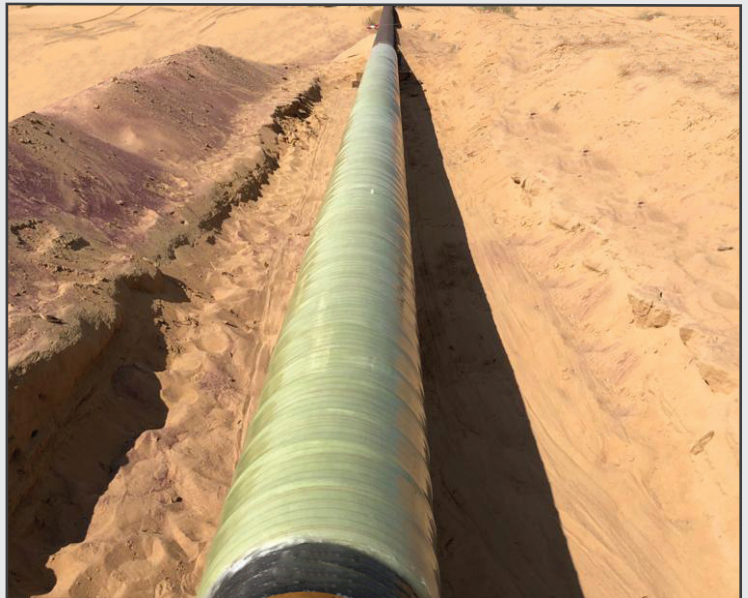
2 Clock Spring® Contour Application

A repair is required that will enable the line to be operated safely.

The proposed solution is the application of Clock Spring® Contour for 14 - layer application.
