# 12" Gasoline Pipeline Repair using ClockSpring® Sleeve

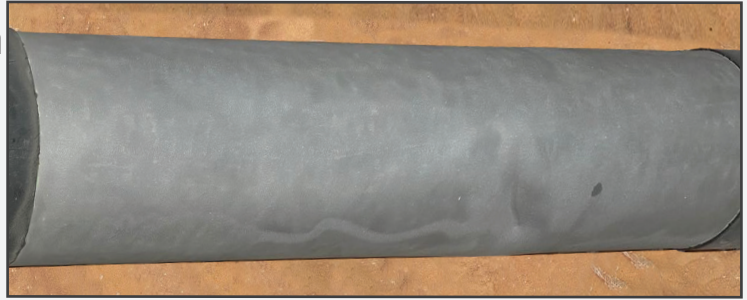
## 1 Coating Removal & Surface Preparation

Identified dent on 12" gasoline pipeline during inspection. Coating removal and surface preparation was carried out to achieve SA2.5 profile by sand blasting. Performed Inspection to ensure that no cracks are present.
