Case Study

SKPS® 18" Gasline External Corrosion Pipeline Reinforcement using CS Composite Wrapping and Viscotaq Coating

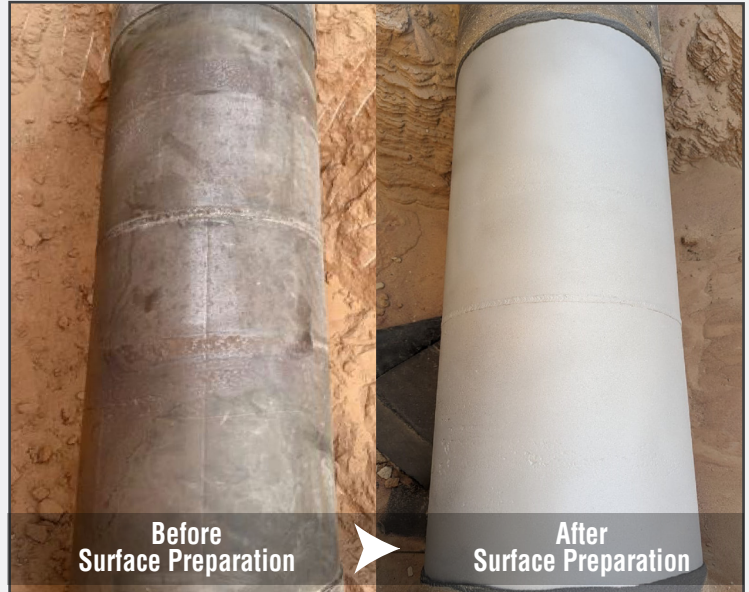
1 Surface Preparation

Pipeline suffered severe external corrosion. Surface preparation was done in SA 2 ½ by blasting. Steel putty has been applied on the wall thinning and uneven surfaces prior to the Clock Spring composite application.

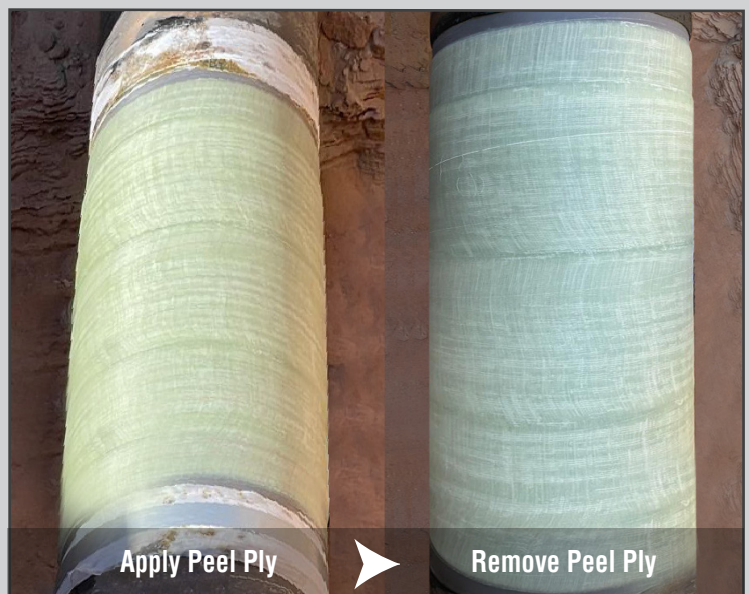
3 Clock Spring Contour Application

A repair is required that will enable the line to be operated safely. The proposed solution is the application of Clock Spring Contour application.

Apply Peel Ply layer on the entirety of pipe, starting beyond the edge of the fabric in a spiral wrap to cover all area. Allow a 3 hour curing time and remove the Peel Ply
