Case Study
Clamped 16" SDV Sealed with
Clock Spring® Contour
Composite Wrapping

Clamped 16" SDV Sealed with Clock Spring® Contour Composite Wrapping

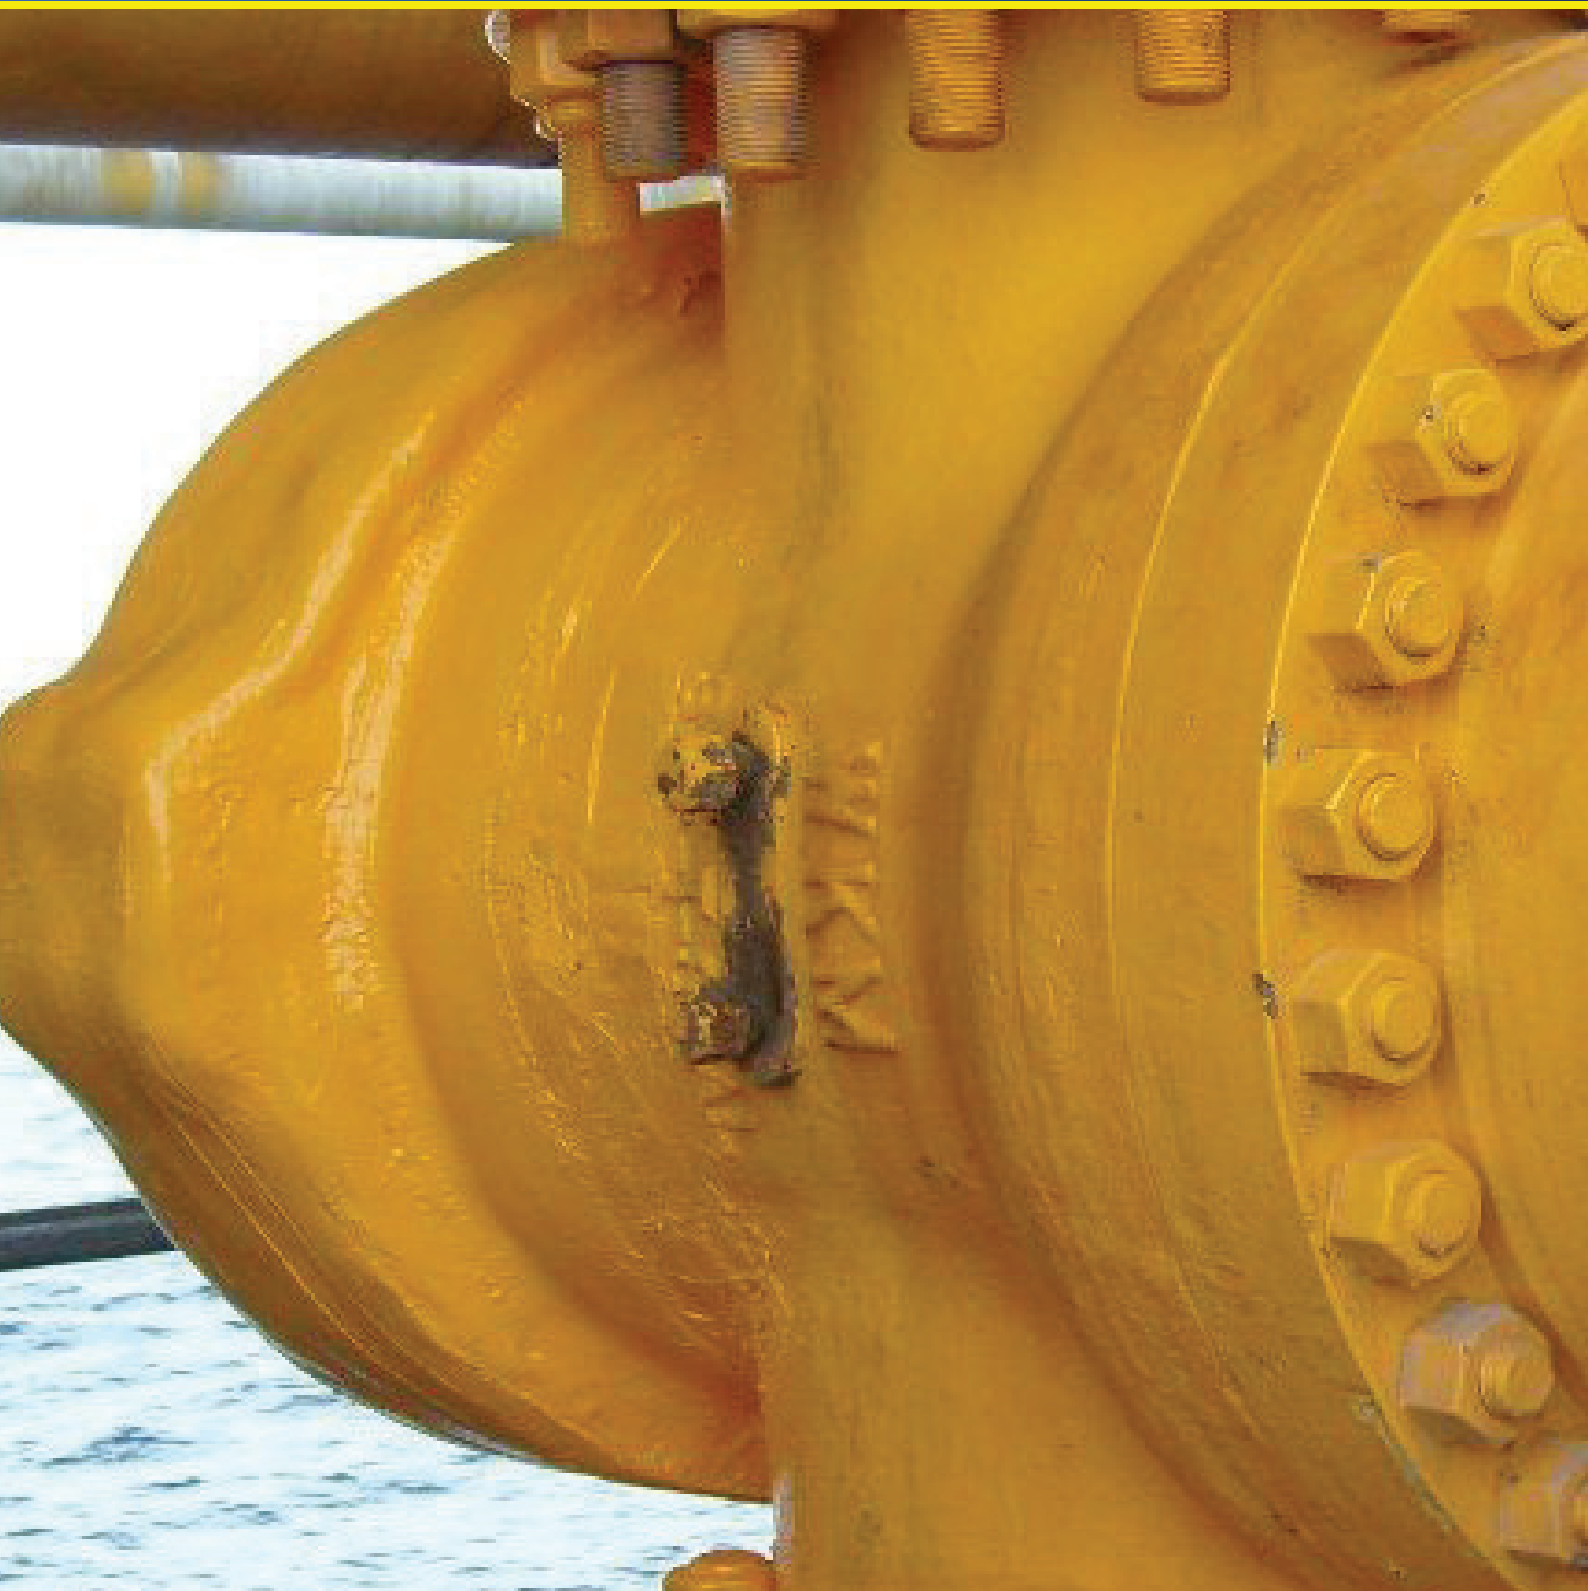
1 Defect area

16" Shut Down Valve suffering a through wall defect was sealed with a leak sealing clamp. Clamped area failed and required an immediate solution to avoid oil from seeping through.

A composite repair was engineered to cover all °360 of the clamp to encapsulate the SDV.
