Case Study 18" Ball Valve Protection using Viscotaq® Viscowrap & Outerwrap

1031/SKPS/CAS/20

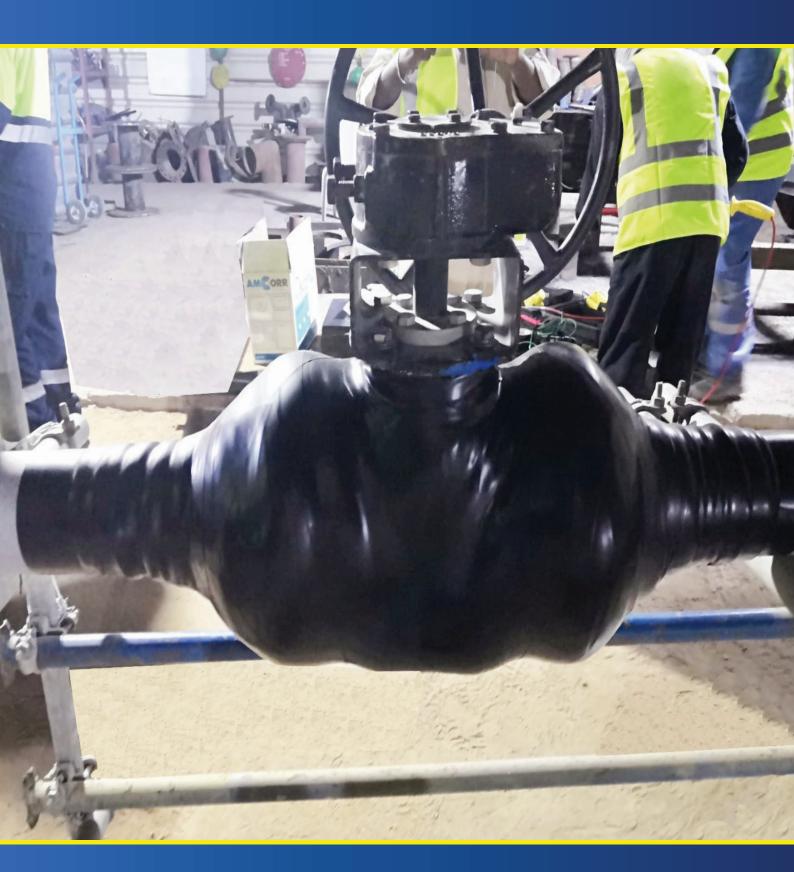
Surface Preparation & Viscotaq® Viscowrap Application

Surface preparation achieved to SA2.5 by sand blasting.

Viscotaq[®] Viscowrap Corrosion Prevention Wrapping for Ball valve.

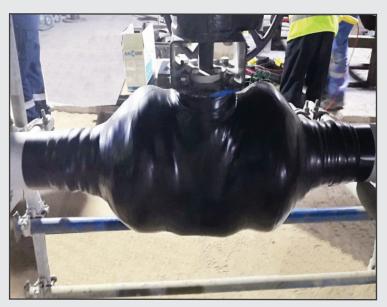
Viscotaq[®] PVC Outerwrap Application

As exhibited, the complete ball valve covered with viscous elastic wrapping tape and outer wrap. Holiday test were carried out before backfill and it took 8-6 hours to complete the application
