## Case Study

# Viscotag Viscous Elastic Wrapping (Viscopaste, Viscowrap HT, PVC & PU composite wrap) on 42" Pipeline

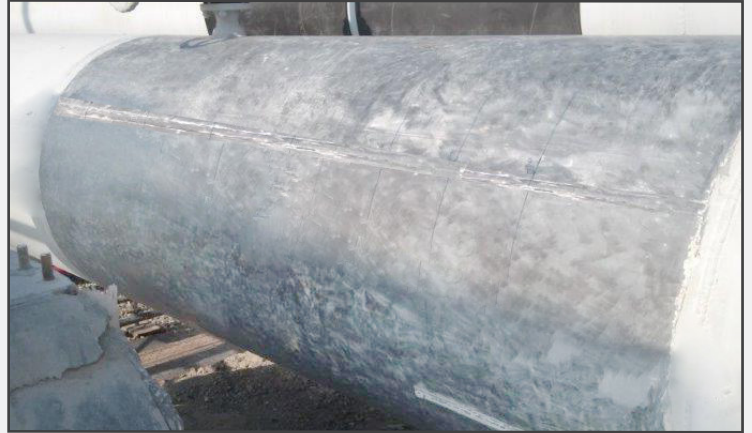
## 1 Surface Preparation

42" Pipeline suffered severe external corrosion. Surface preparation up to St2

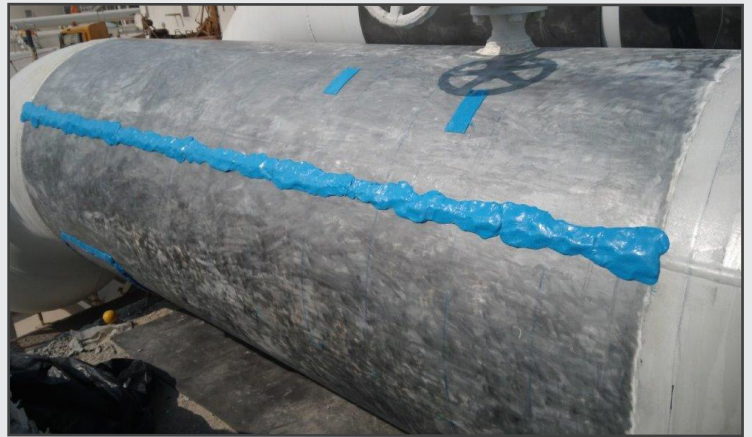
## 2 Viscotag® Viscopaste Application

Apply Viscotag® Viscopaste over the welded area and uneven surface.

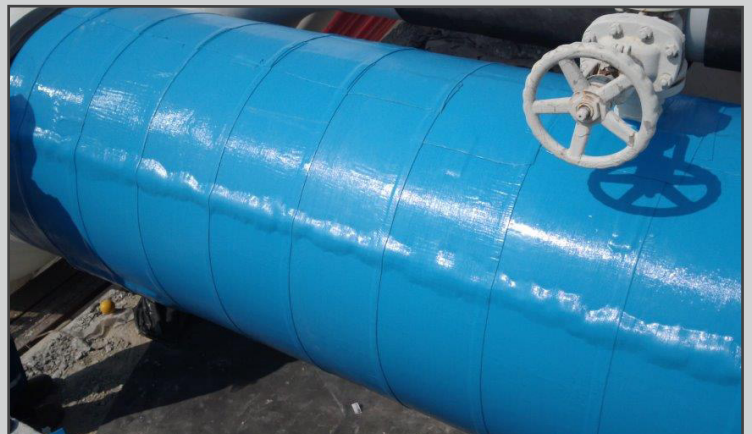
## 3 Viscotag® Viscowrap Application

Viscotag® Viscowrap HT is applied by removing the release liner and placing adhesive side on the pipe. Initial wrap should be a straight circumference wrap. Once initial straight circumference wrap is completed, wrap with slight tension and a minimum 1/2" overlap.

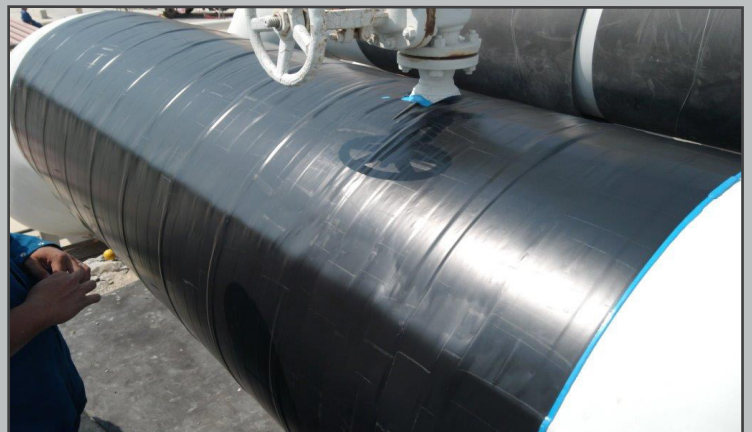
## 4 Viscotag® PVC Outerwrap Application

Outer Wrap should be wrapped with tension and a minimum of 50 % overlap. First wrap and termination wrap should be a straight circumference wrap

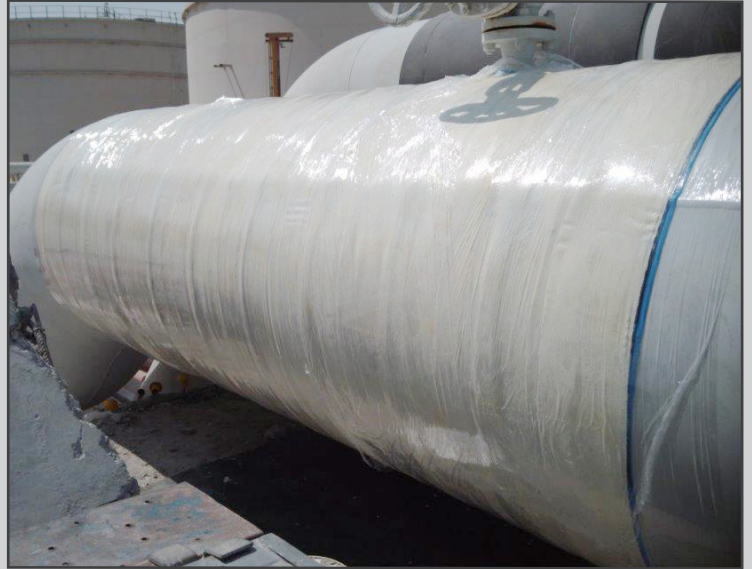
## 5 Viscotag® PU Composite Wrap Application

As an additional mechanical protection, Viscotag PU polyurethane layer with 66 % overlap over the PVC layer.

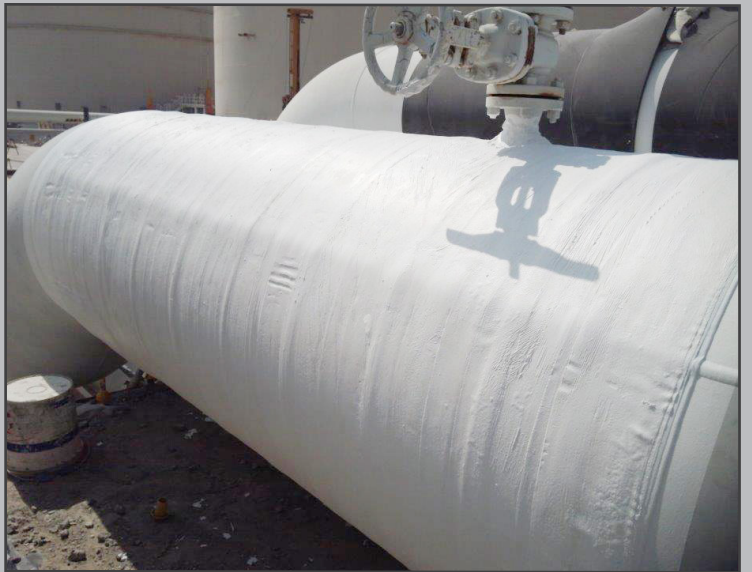
## 6 UV Resistant Top Coat

The final layer has to be painted with a UV Resistant Top Coat.
