Case Study

Cold Work – Handrail Repair

Kits for Repairing Corroded Handrail Repairs

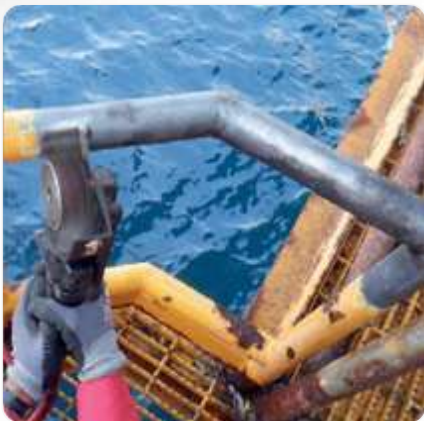
01- Surface Preparation

Prepare the surface to St2 or St3 standards, clean with Acetone/MEK, and mark with Multi-Surface Painter's Tape.

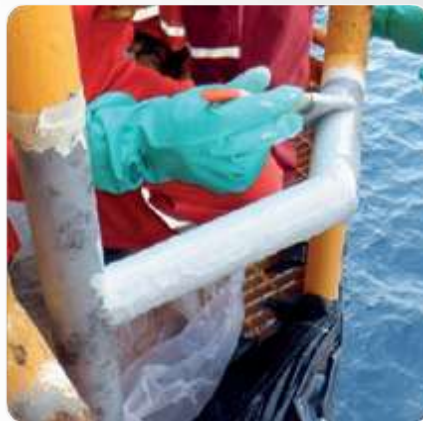
02- Compound on Anomaly Area

Pour hardener (part B) into part A, mix for at least 5 minutes, then brush anomaly with compound for a metal plate cushion.

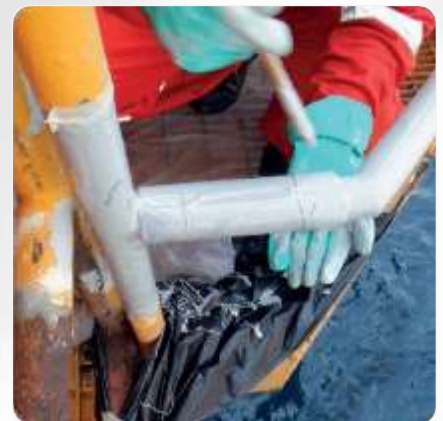
03- Sleeve Application on Compound

Apply Protectolast SR, attach sleeve plate with wire, brush with compound, chamfer edges.

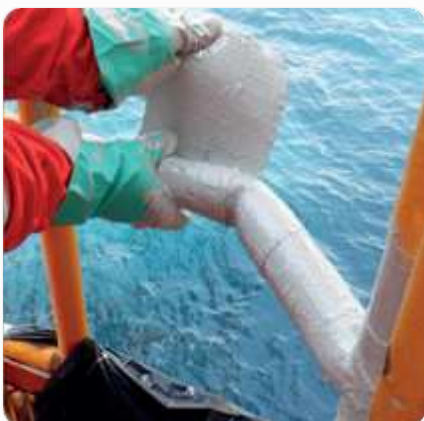
04- Glass Fiber Application

Cut two layers of glass fiber, spread compound, wrap over metal plates to cover anomaly.

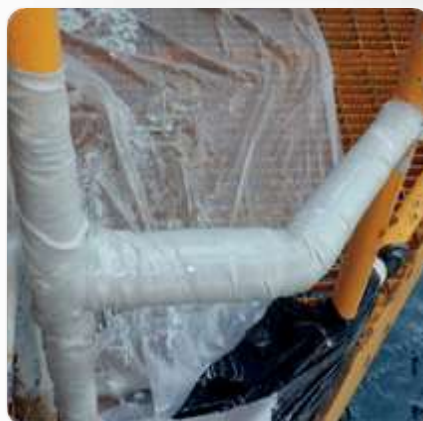
05- Final Application

Apply final Protectolast SR layer, cover with peel ply, and remove after 4 hours of curing.
