Case Study

Viscotaq Viscous Elastic Wrapping (Viscopaste, Viscowrap HT, PVC & PU composite wrap) on Soil to Air Riser

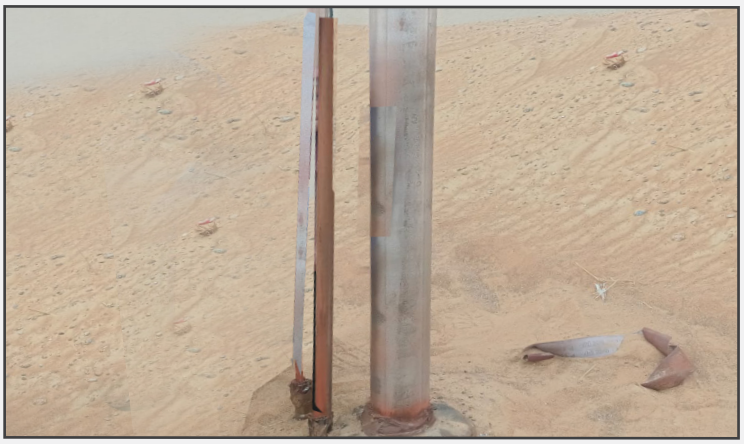
1 Surface Preparation

Pipeline suffered severe external corrosion. Surface preparation up to St2
