24" Repair of Sea Water Header Leakage Composite Repair Case Study

24” Repair of Sea Water Header Leakage (Tee Joint)

Location: Abu Dhabi, U.A.E.

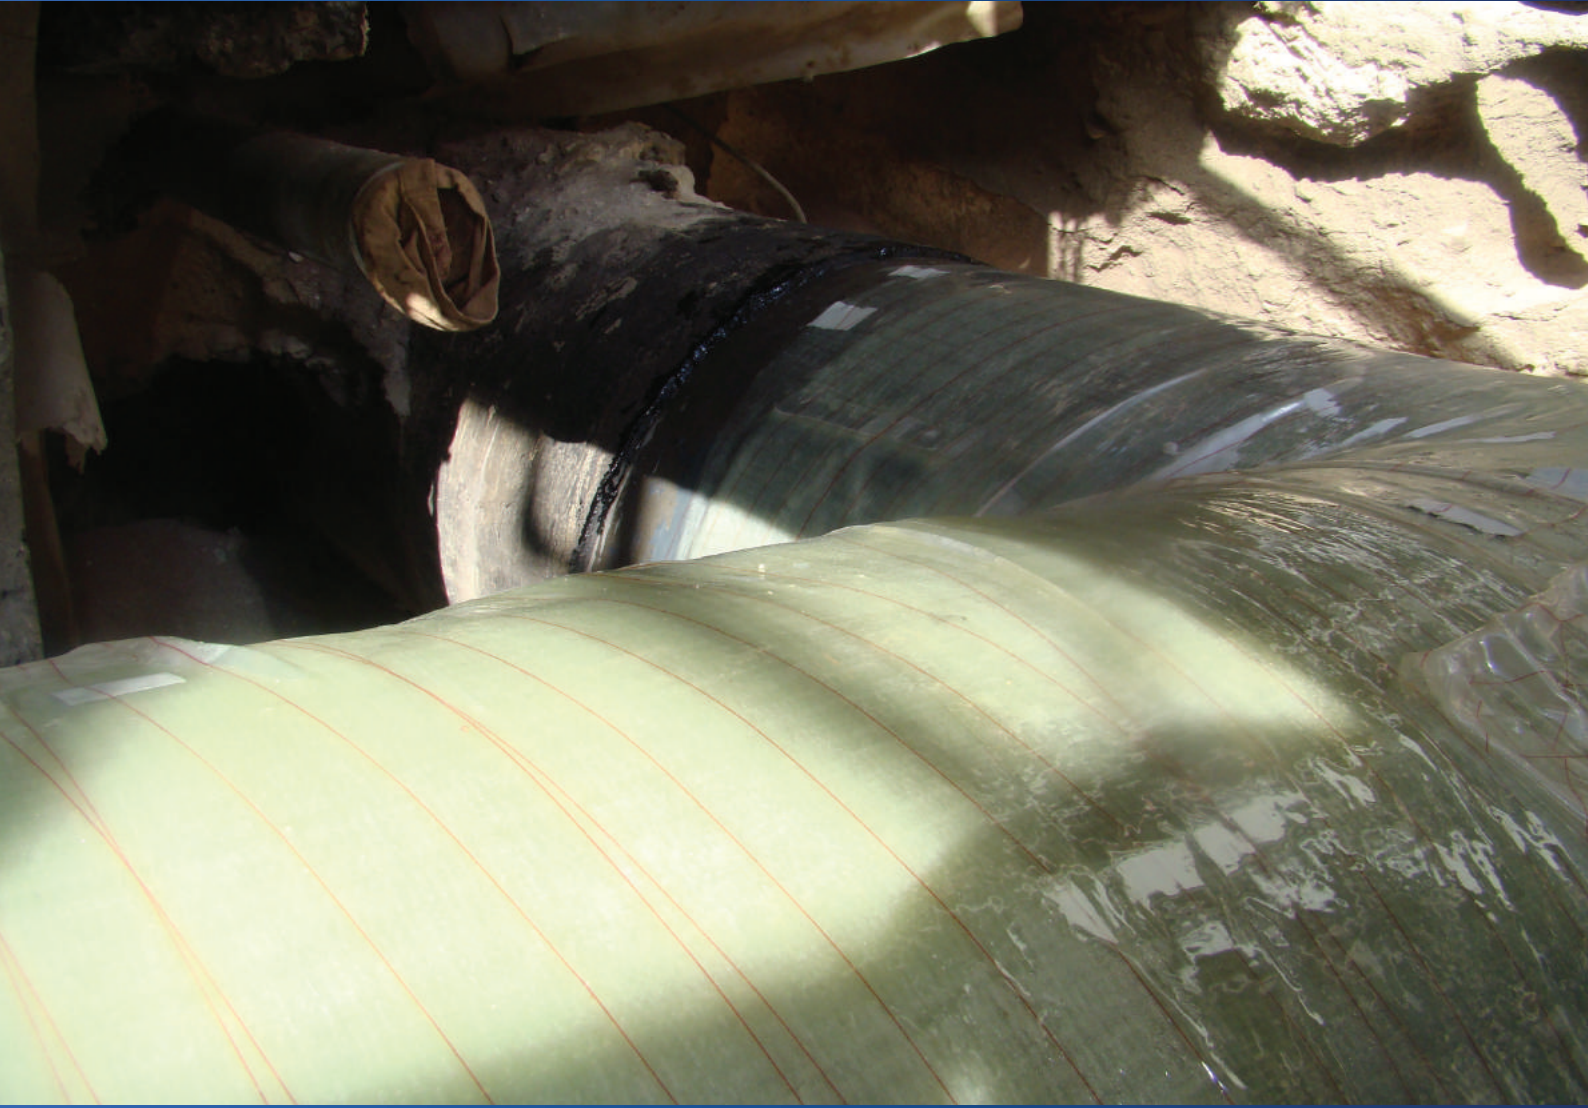
01

(Fig. I):- A 24” Tee joint sea water header had through wall metal loss and water leakage due to internal corrosion. The leak was arrested by welding a 10” pipe branching off at the 6 O’clock position.
