**FRP Pipe Leak Repair using
Clock Spring® Contour (1500mm dia)**

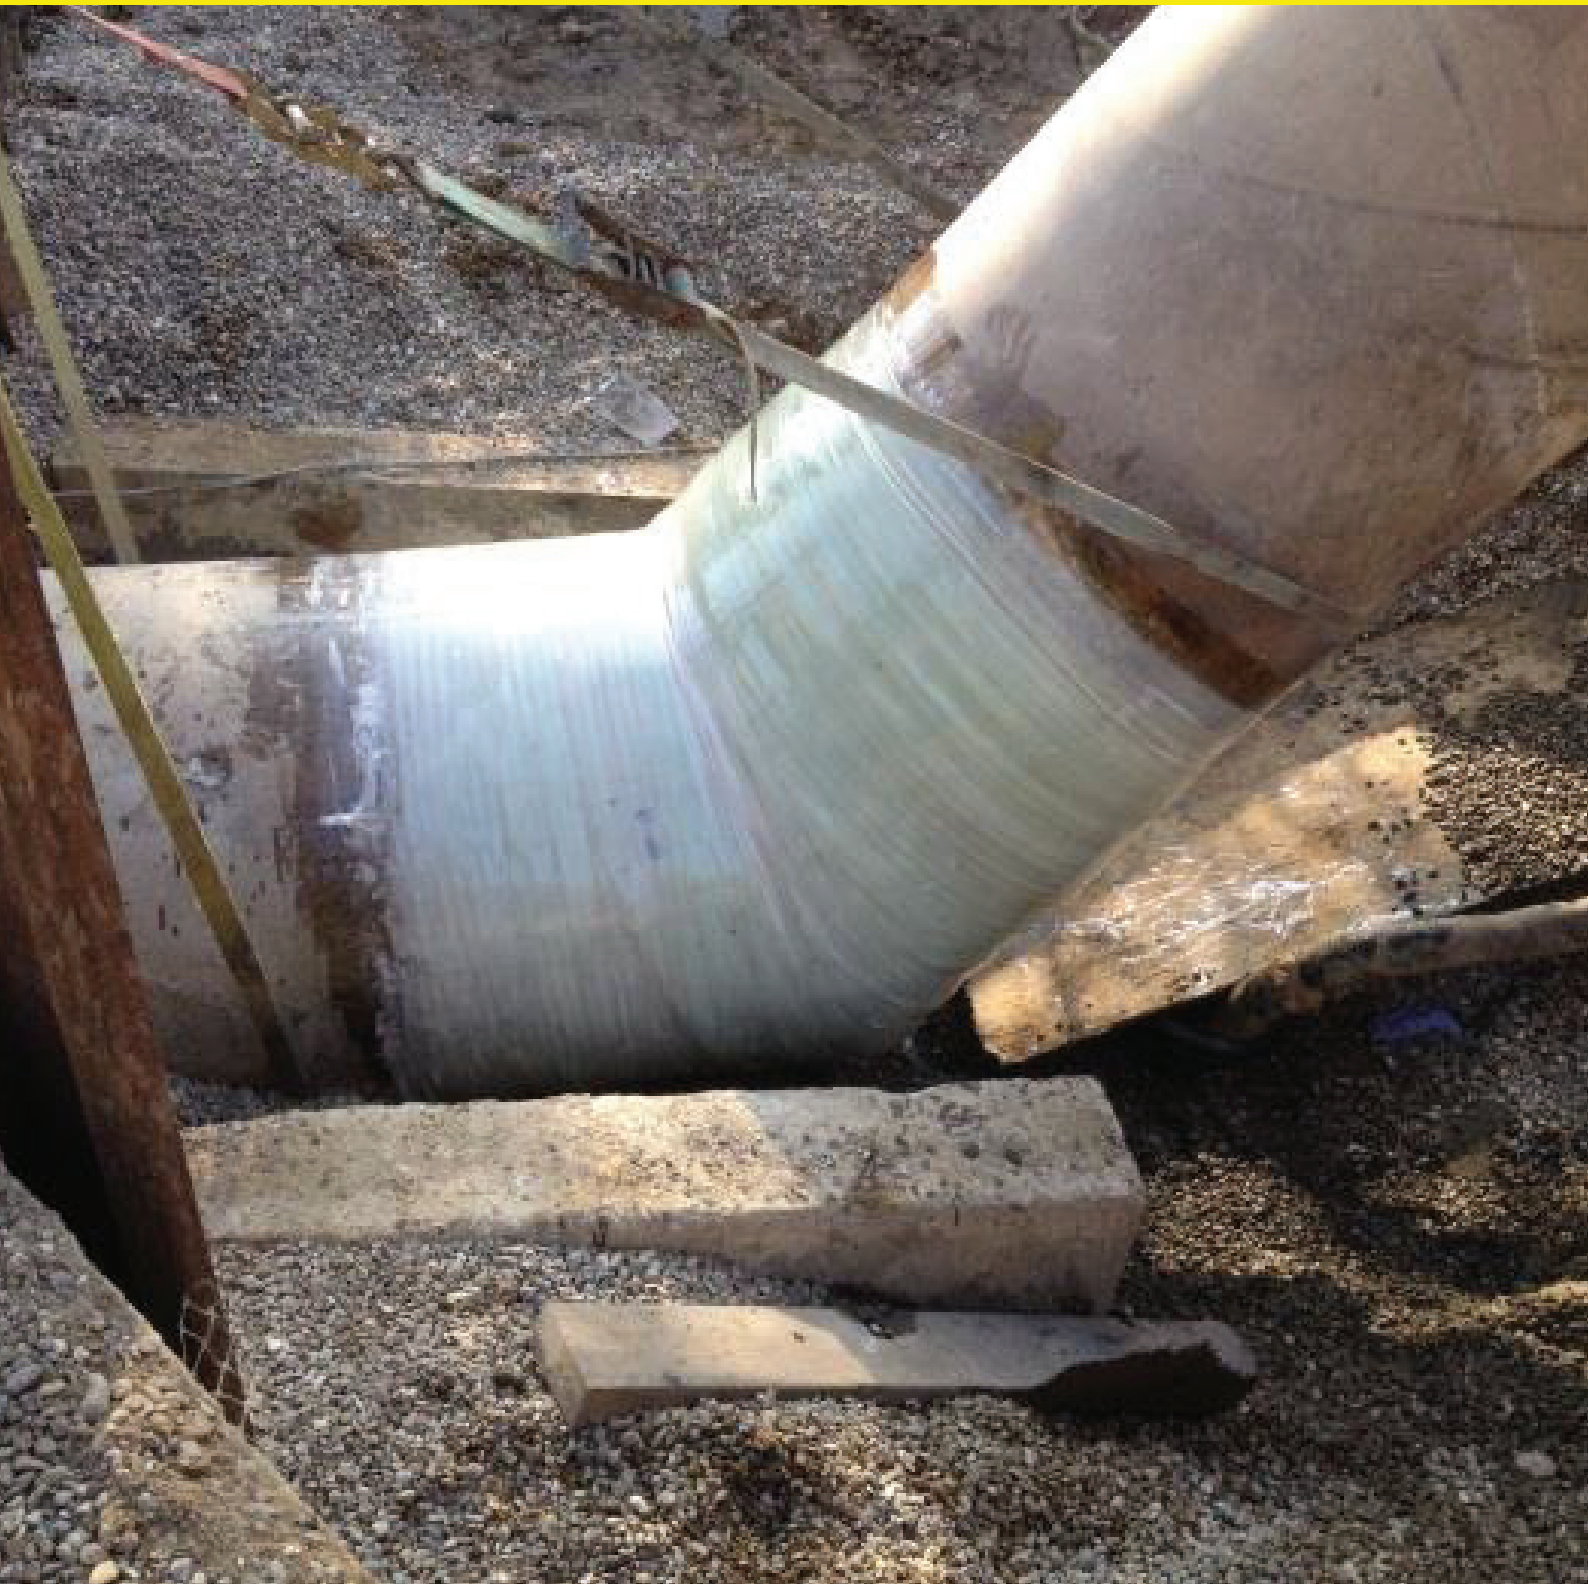
Ground movement had caused a crack at a miter bend location which with applied stresses had caused a failure in the body of the main pipe. Leak found and line drained.

The line was removed from service and the crack closed by moving the pipe back into the correct position and supported in place. The line was then cleaned using sand paper back to the original glass fibre surface.

All cracks were sealed using metal plates and epoxy putty. Multiple layers of Clock Spring Contour were applied in one shift to complete the repair. The repair was then supported on tampered gravel to prevent any further movement of the pipe.
