Case Study
4", 6" and 8" Riser Repairs Offshore
Viscotag® (Viscous Elastic Coating)

4", 6" and 8" Riser Repairs Offshore Viscotaq® (Viscous Elastic Coating)

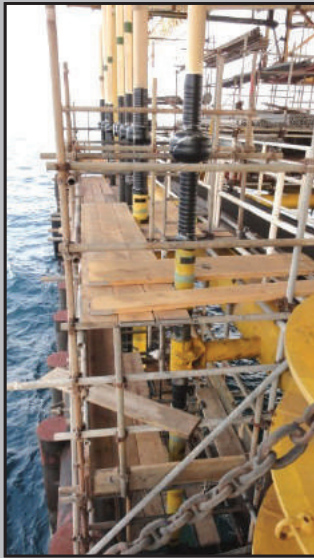
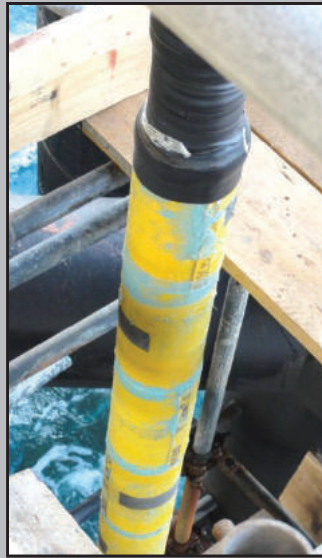
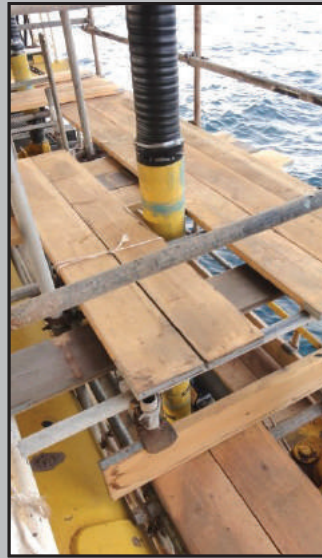
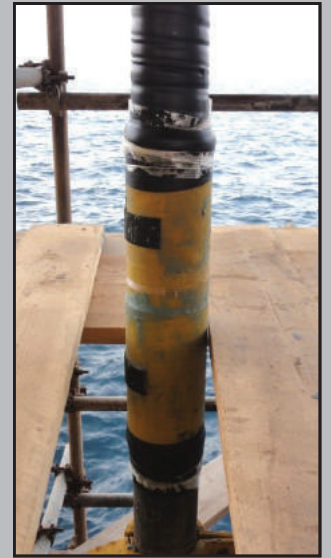
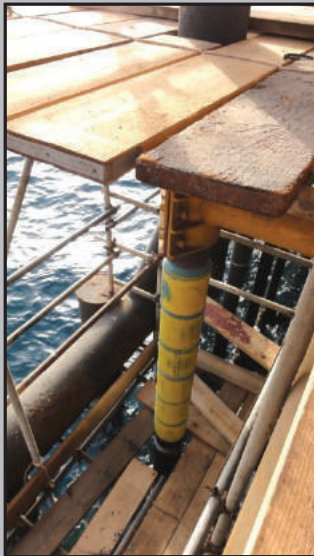
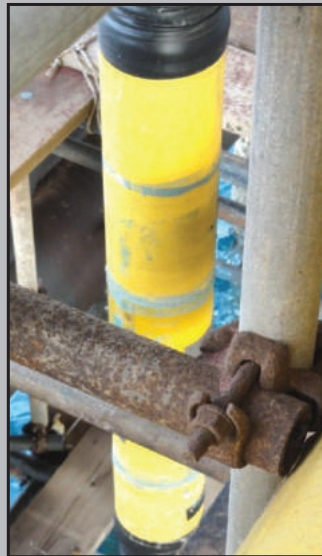
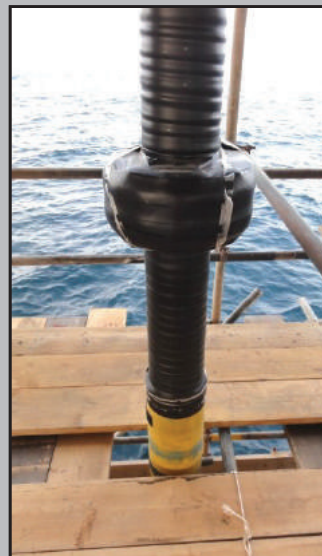
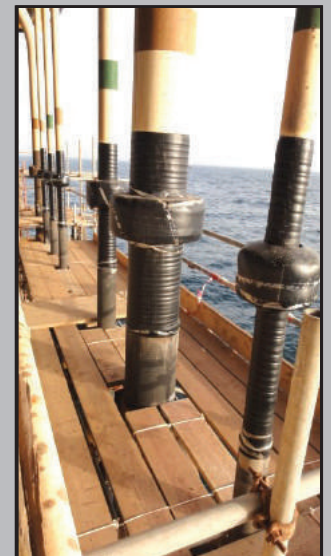
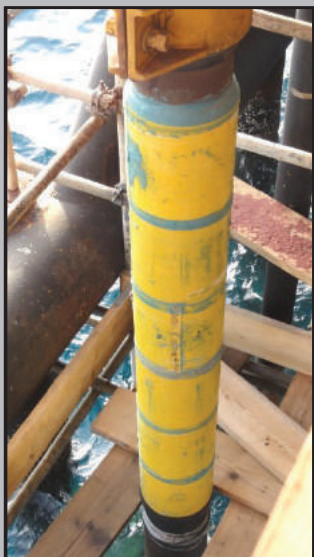
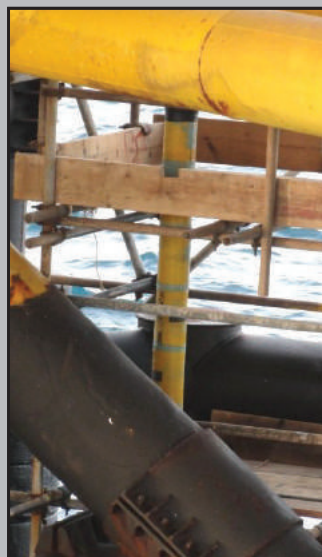
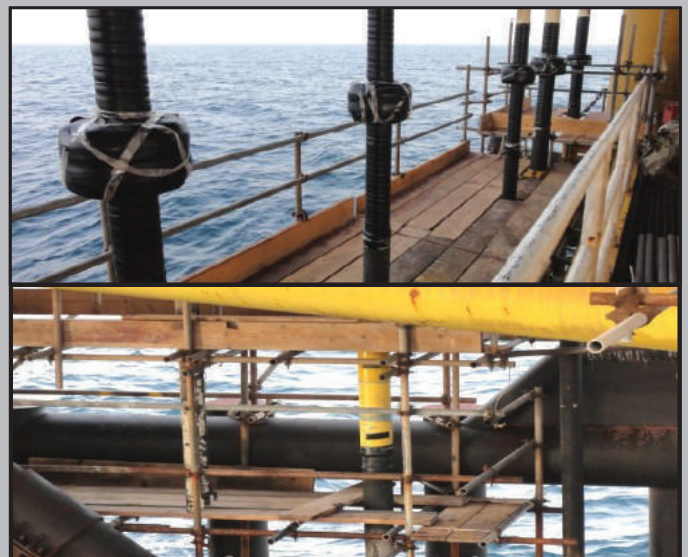
The completed repair after the Clock Spring Installation and application of the Viscotaq. Two (2) Certified Clock Spring Engineers from SKPS and 5 days to complete a scope of 4x, "4 7x6" and 6x8" risers Also attached additional photographs of this application.
