Case Study 20" Heavy Oil Fuel Line Repair

1027/SKPS/CAS/20

20" Heavy Oil Fuel Line Repair

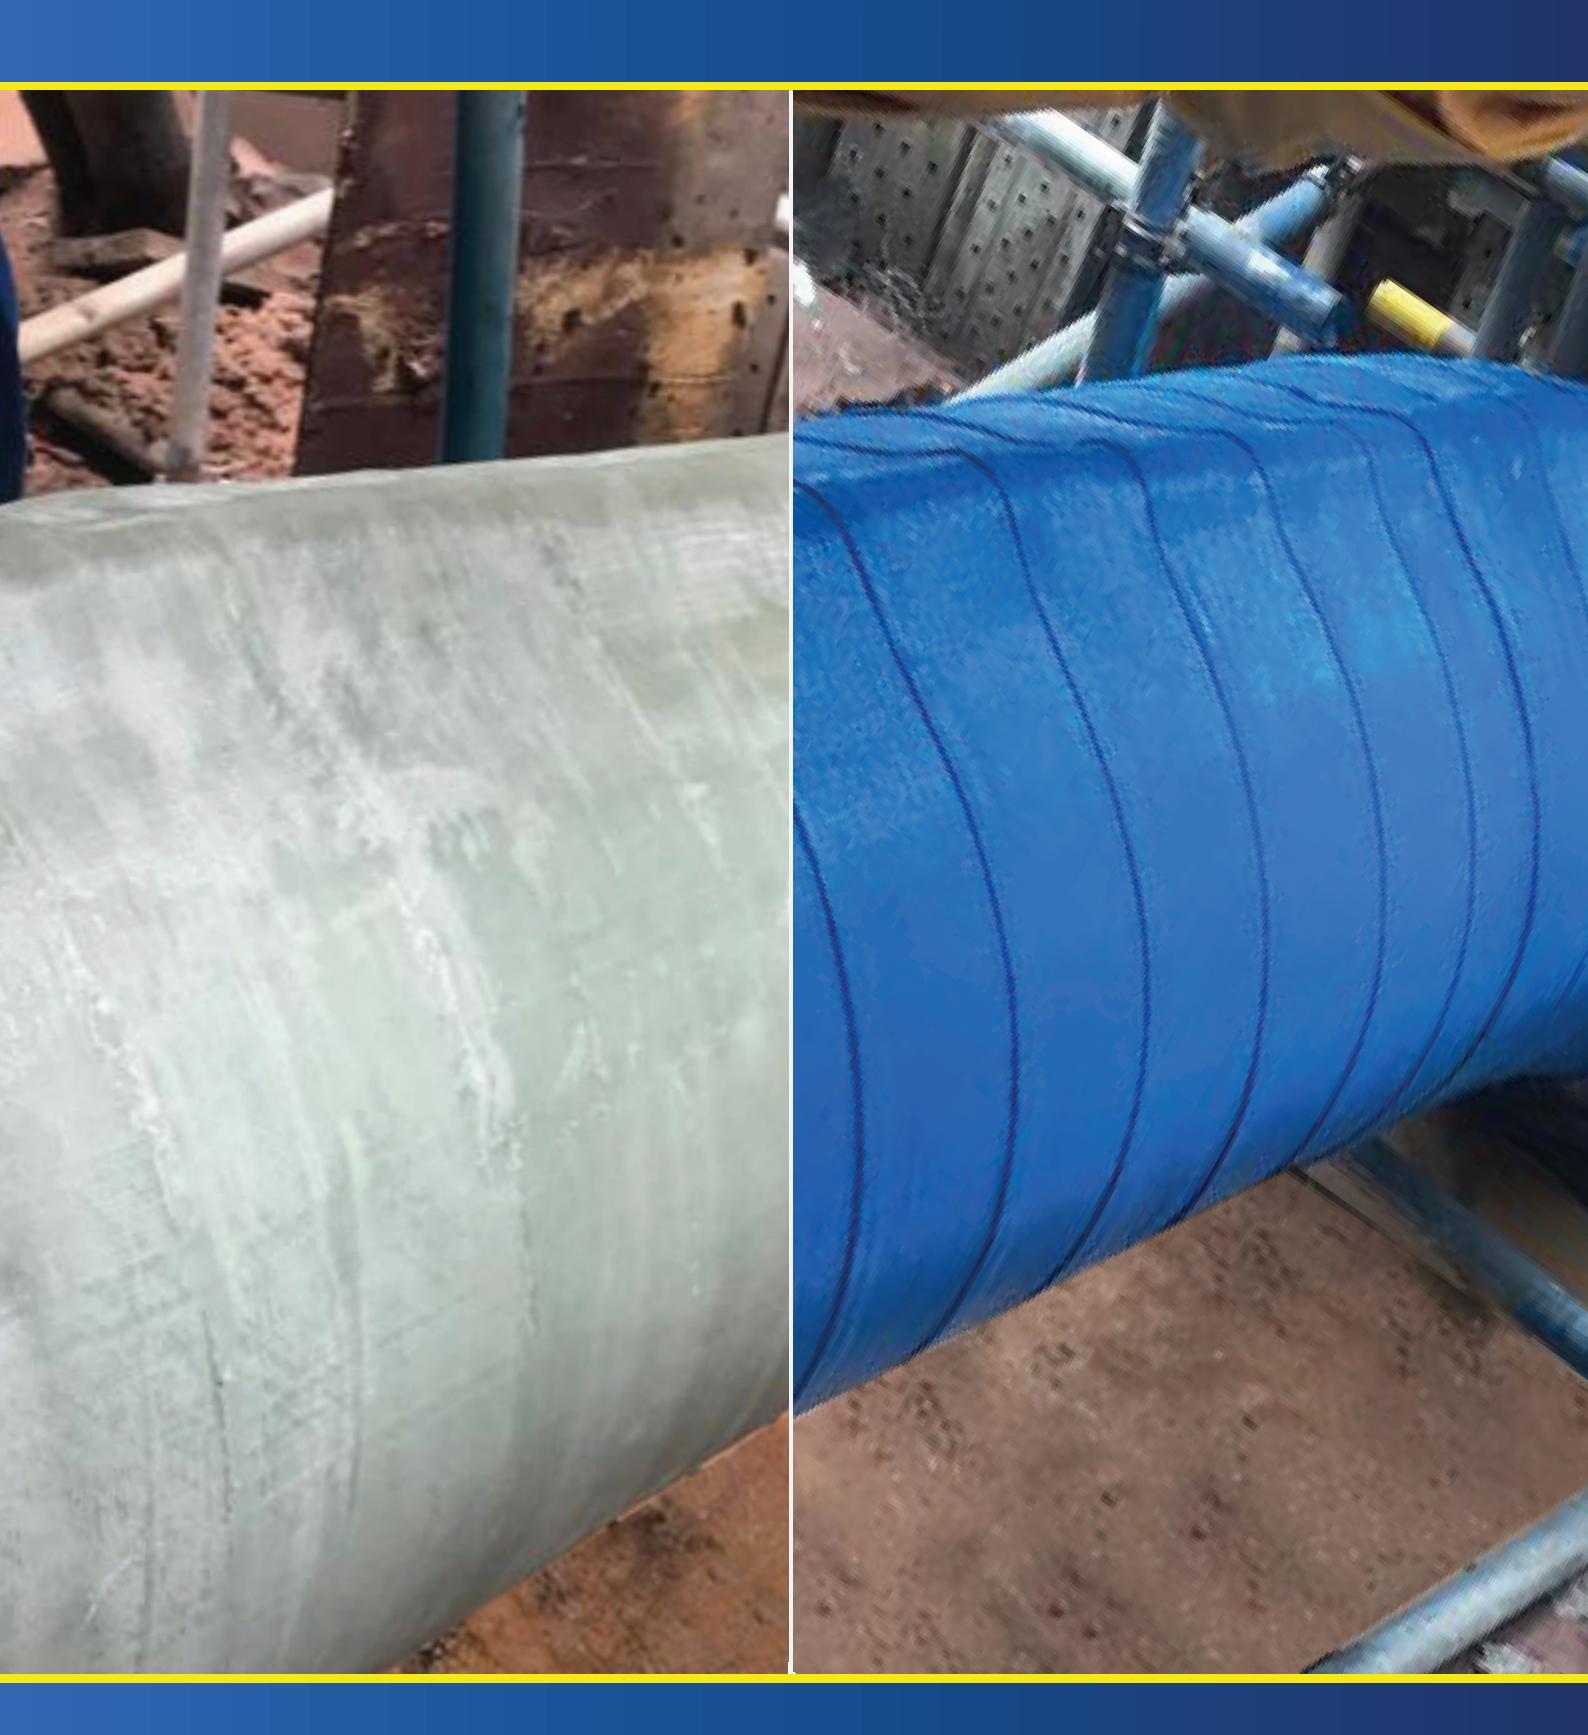
Surface Preparation

20" heavy fuel oil line found severe external wall loss due to coating/insulation damage. Heat tracing cable was exposed due to corrosion leading to fluctuations while operation. Pipe surface preparation achieved to SA2.5 by sand blasting.
