Clamped 16” SDV Sealed with Clock Spring Contour Composite Repair

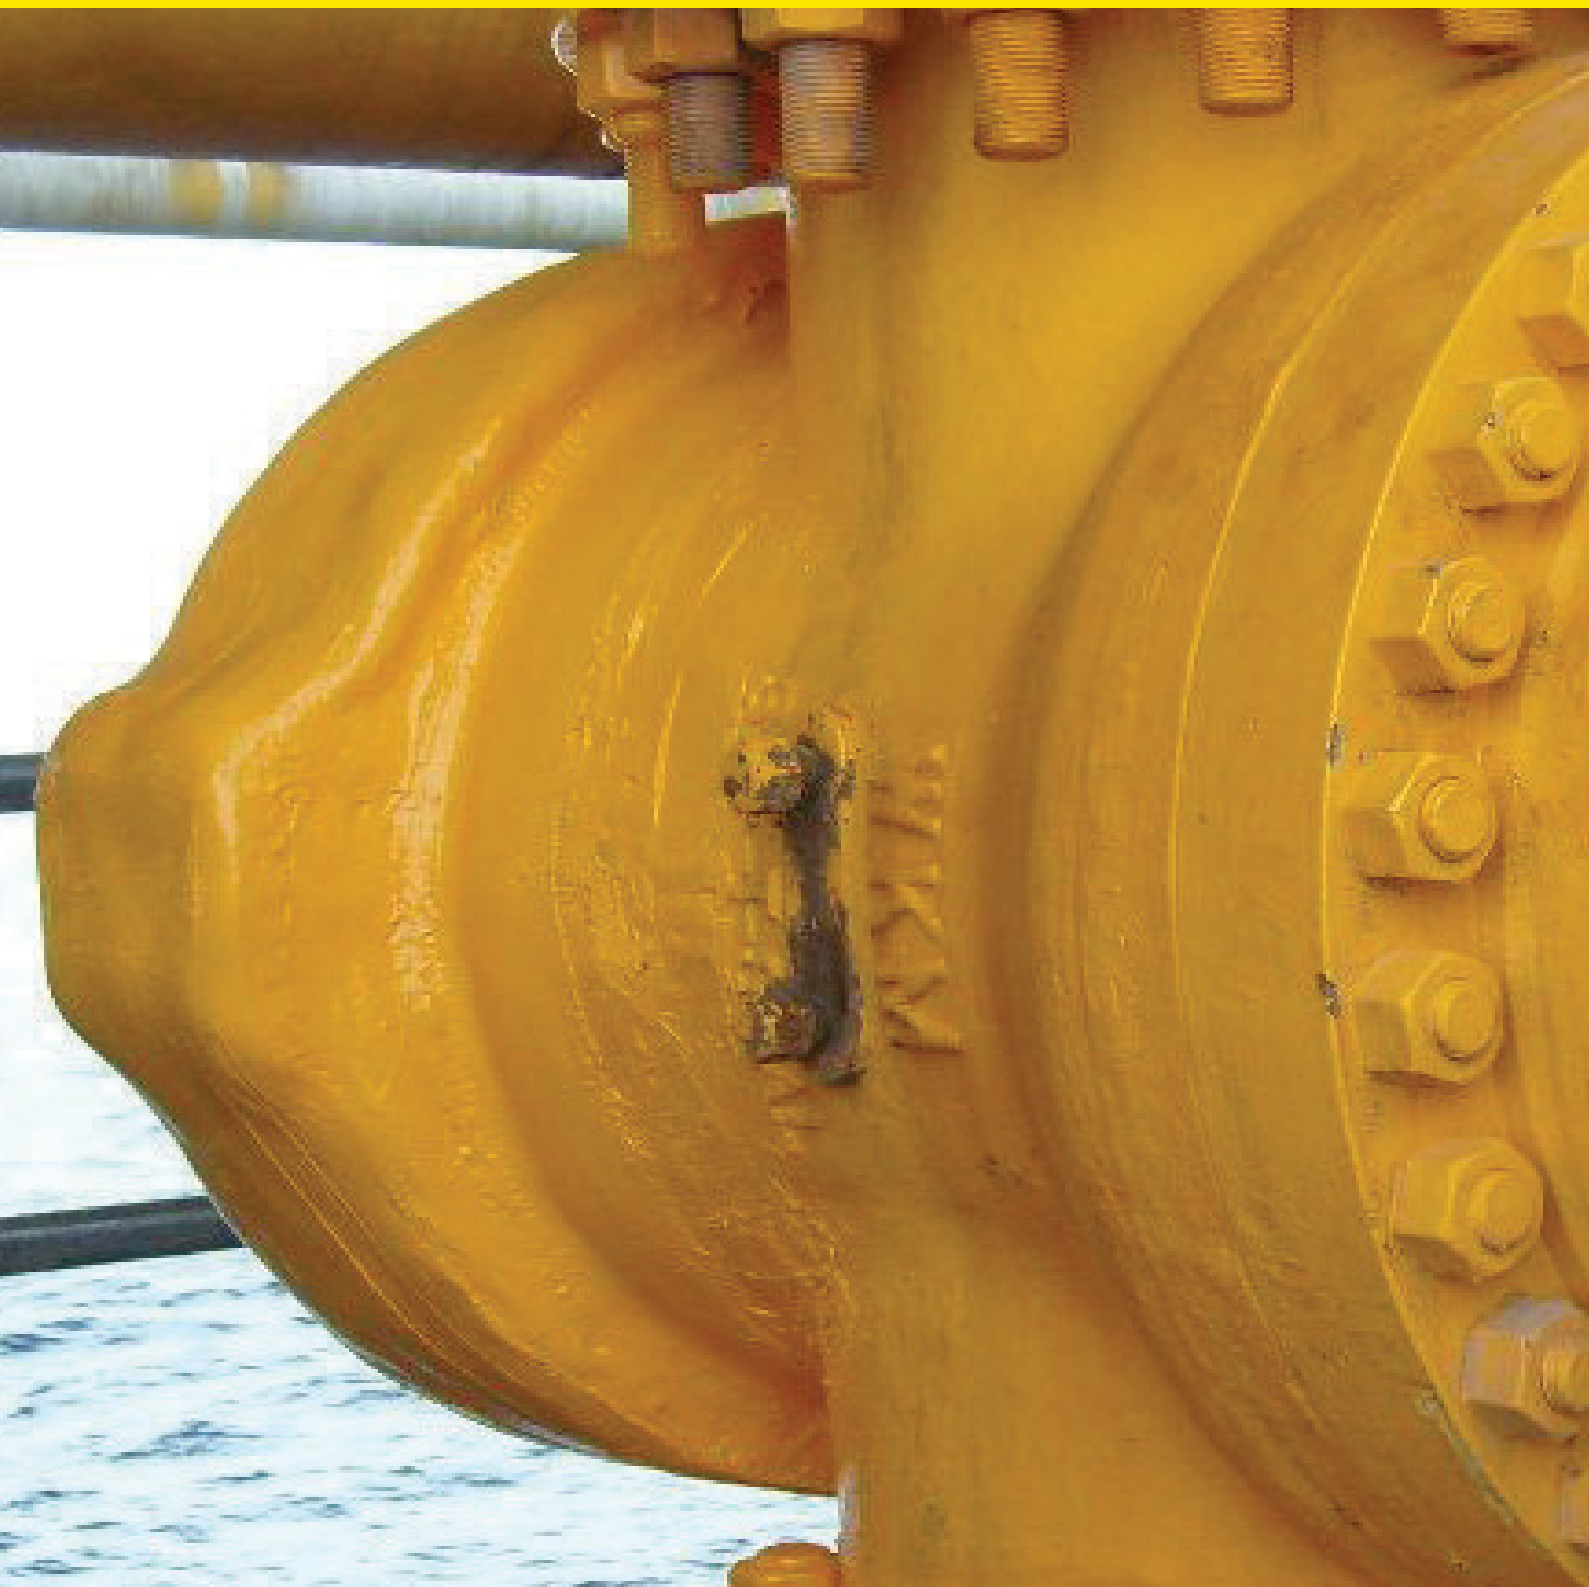
1 Repair Area

16” Shut Down Valve suffering a through wall defect was sealed with a leak sealing clamp. Clamped area failed and required an immediate solution to avoid oil from seeping through.

A composite repair was engineered to cover all 360° of the clamp to encapsulate the SDV.
