**2" x 30" Nozzle Repair Clock Spring®
Contour Composite Wrapping**

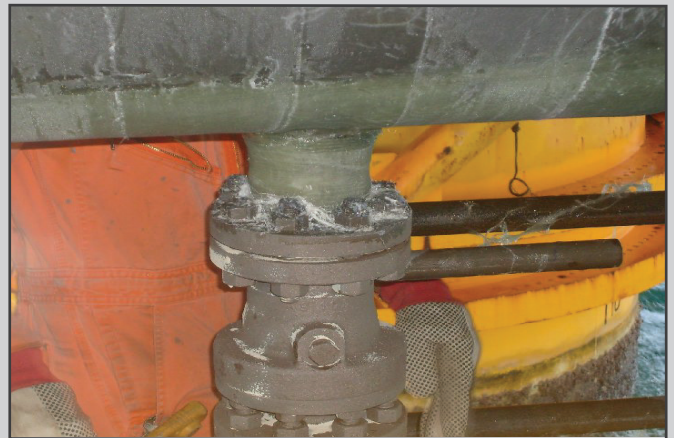
4 Design Criteria

The Final repair.

Operating Temperature	: 120° F
Operating Pressure	: 80PSI
Defect Type	: Internal Corrosion
Size	: 2 inch weldolet
Design Pressure	: 250PSI
Defect Analysis	: Wall thinning with metal loss up to 50 %
Lifetime	: 5Years
