18" Trunk Line Clock Spring® Composite Wrapping

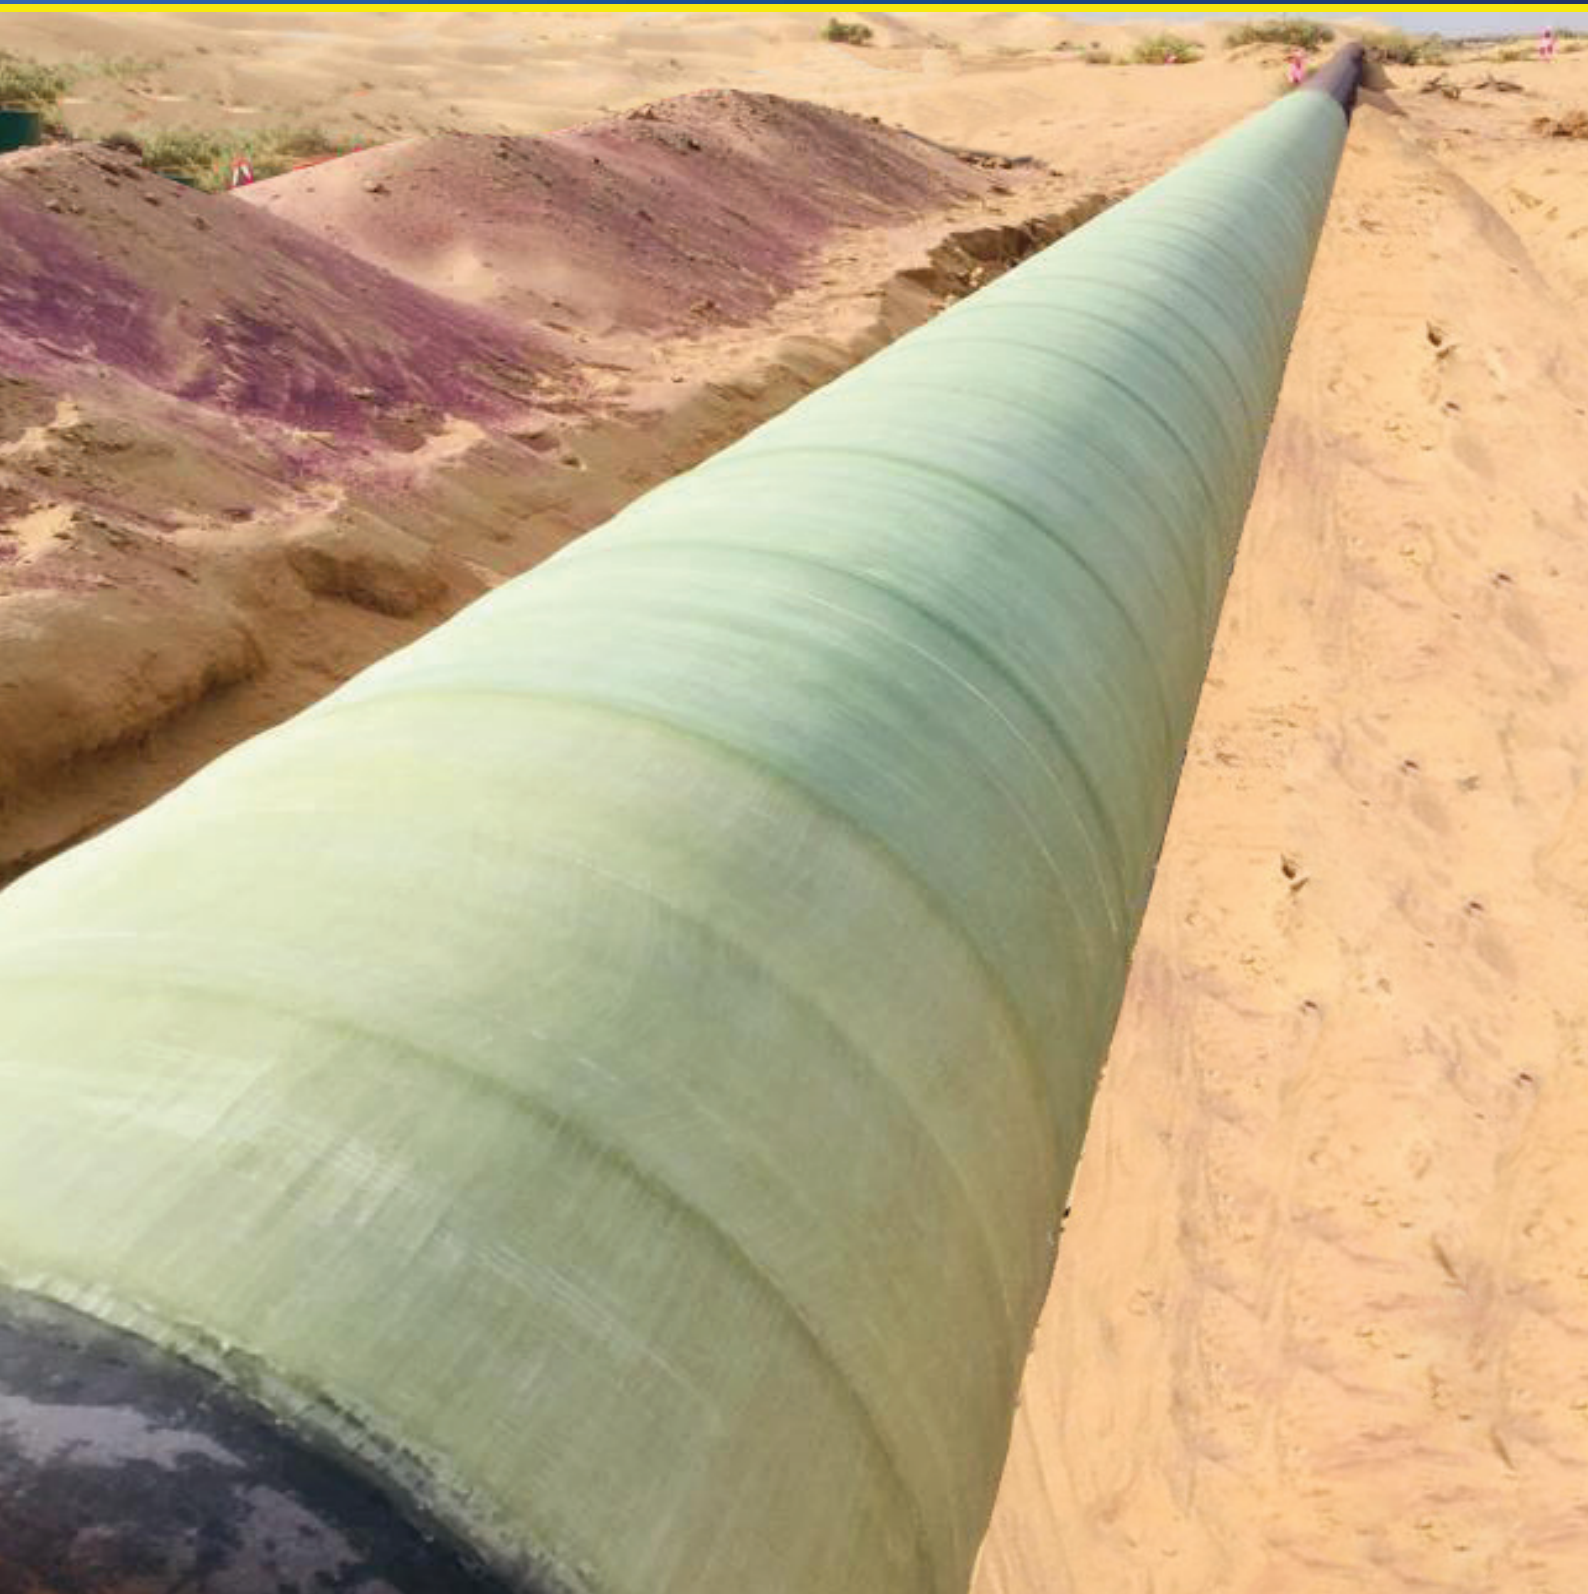
Inspection on 18" trunk line has highlighted external corrosion on 2 locations.

Surface preparation was done in SA 2 ½ by blasting. Steel putty has been applied on the wall thinning and uneven surfaces prior to the Clock Spring® composite application.
