Case Study

SKPS® 18" Gasline External Corrosion Pipeline Reinforcement using CS Composite Wrapping and Viscotaq Coating

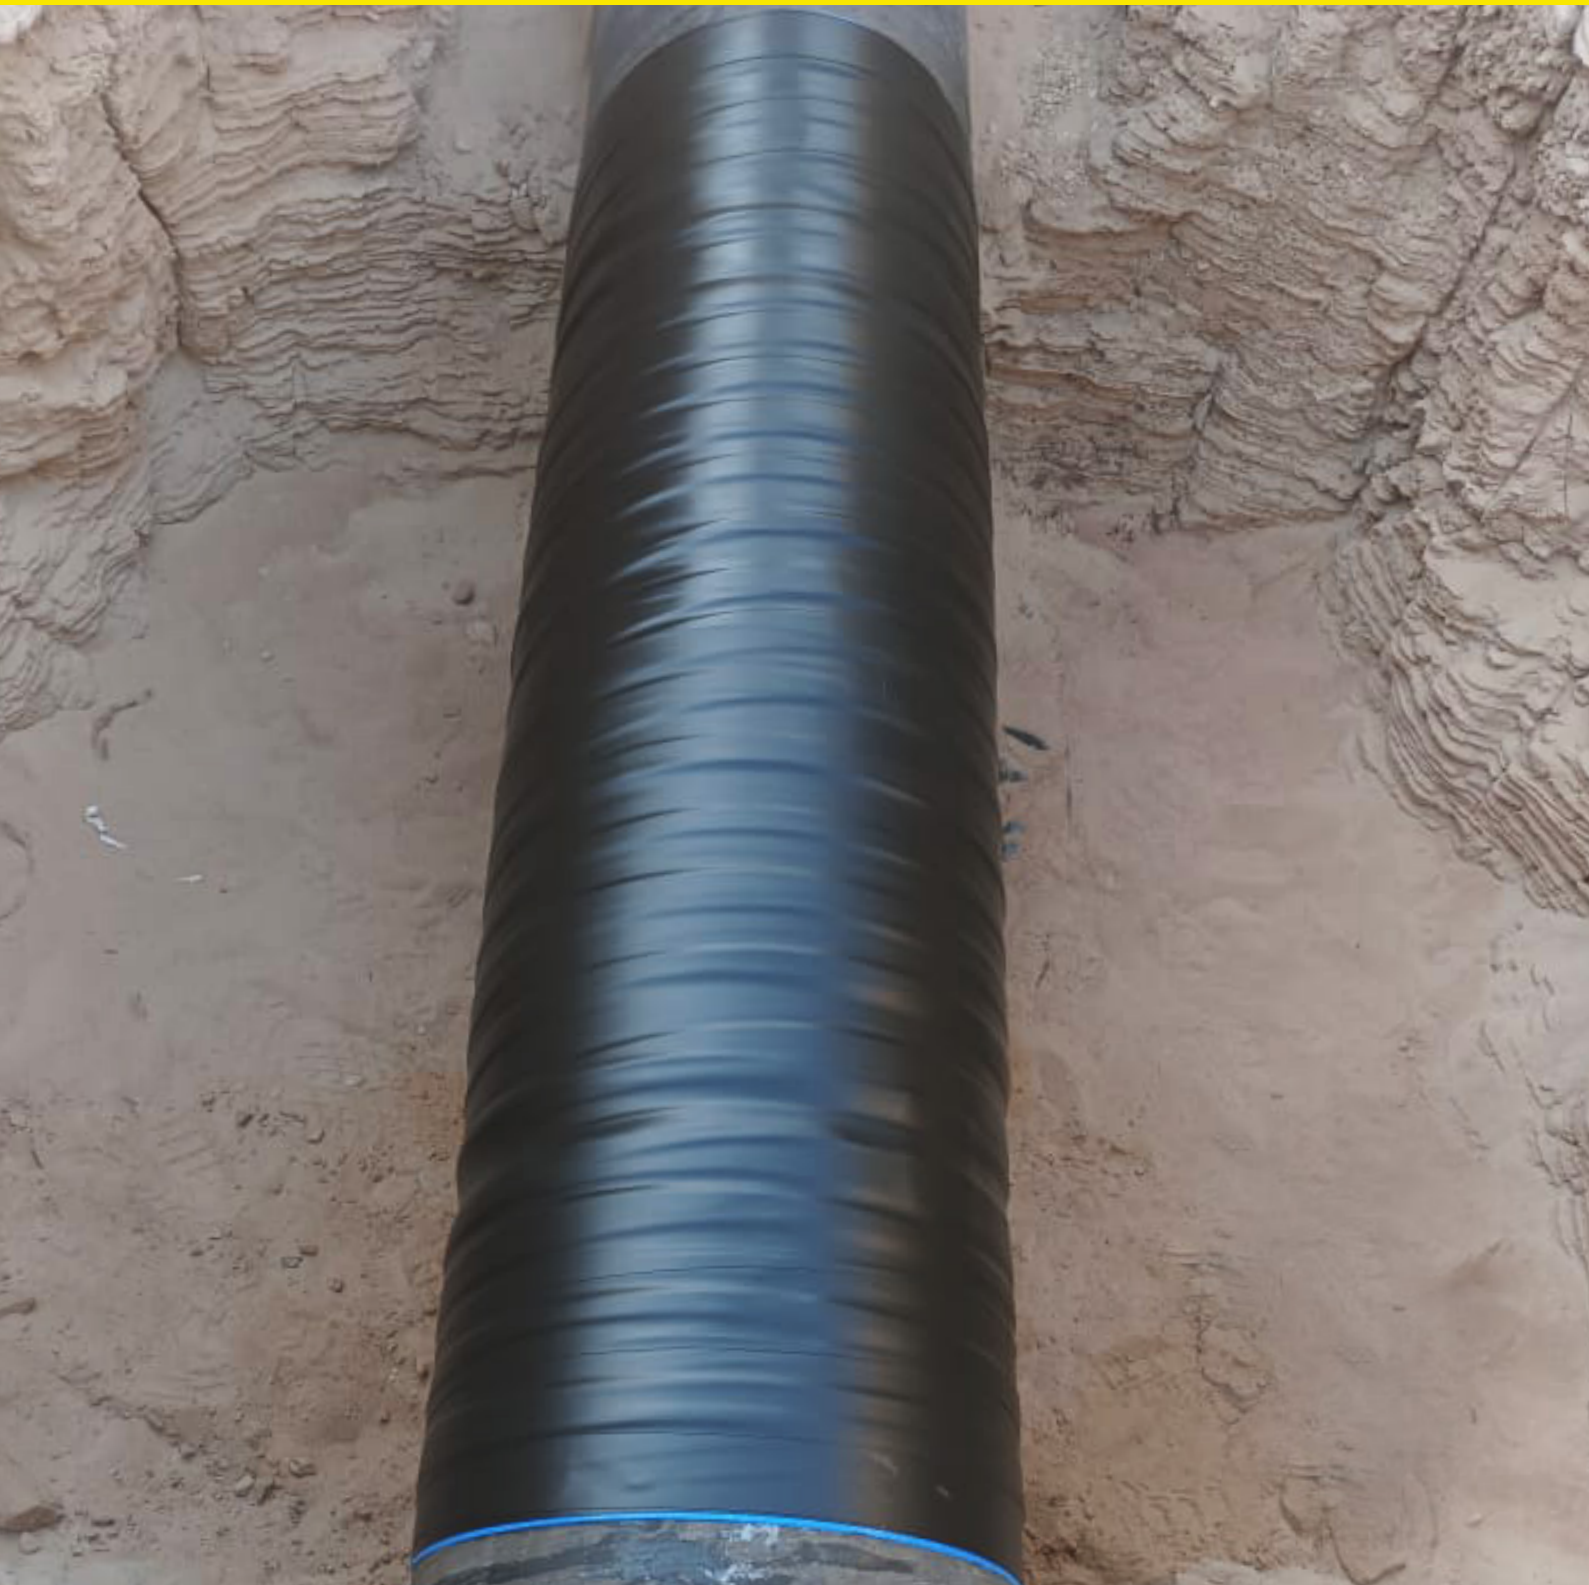
Pipeline suffered severe external corrosion. Surface preparation was done in SA 2 ½ by blasting. Steel putty has been applied on the wall thinning and uneven surfaces prior to the Clock Spring composite application.
