Case Study Tank Chime Sealant System

Tank Chime Sealant System

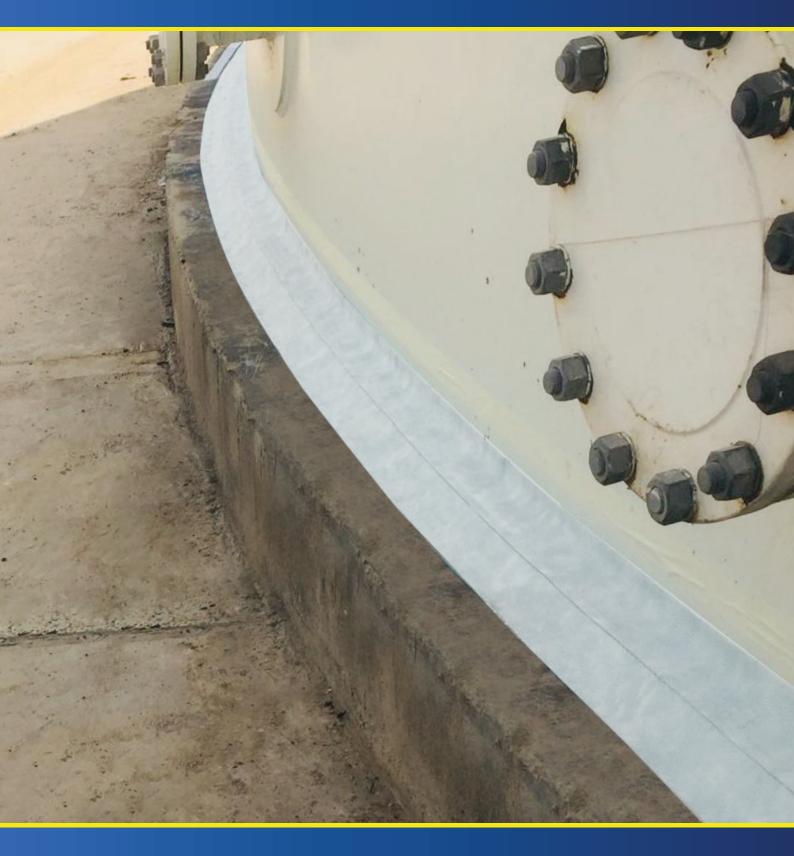
Identification	: Tank
Diameter	: 27 Meter
Defect Type	: External Corrosion
Objectives	: Reduce the corrosion rate and extend the life of metal surface
Material	: Sealant
Defect Analysis	: Annular plate & tank bottom were corroded due to exposure to ambient conditions.
Life time	: 5 years.

Surface Preparation

Remove any loose particles, hand tool clean to minimum of ST2/SSPC-SP2. Wipe down area to be coated with Dentatured alcohol or acetone.
