Case Study

Viscotag Viscous Elastic Wrapping (Viscopaste, Viscowrap HT, PVC & PU composite wrap) on 42" Pipeline

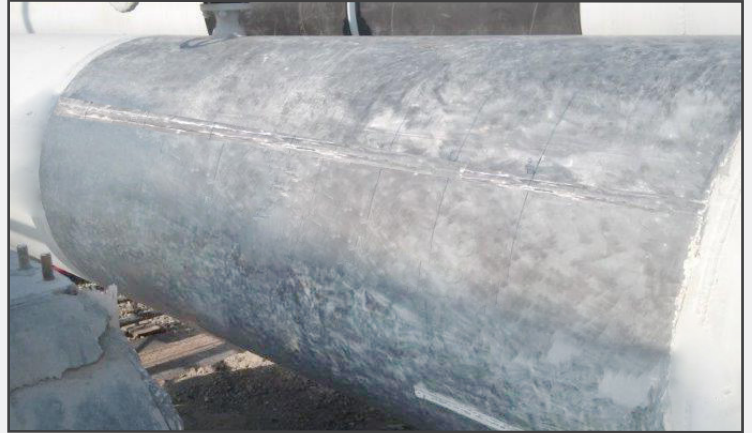
1 Surface Preparation

42" Pipeline suffered severe external corrosion. Surface preparation up to St2

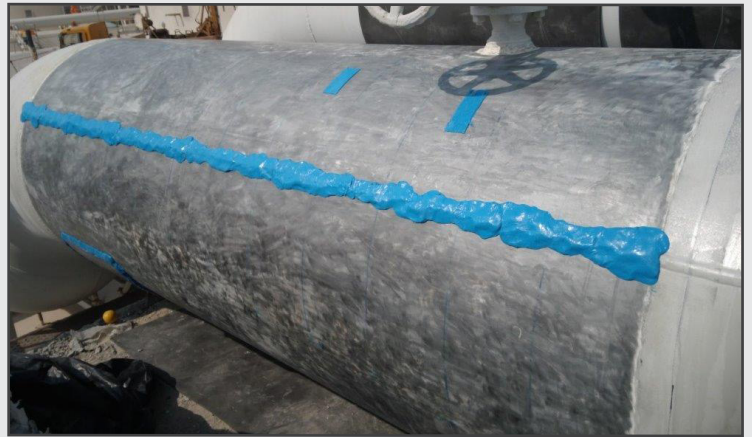
2 Viscotag® Viscopaste Application

Apply Viscotag® Viscopaste over the welded area and uneven surface.

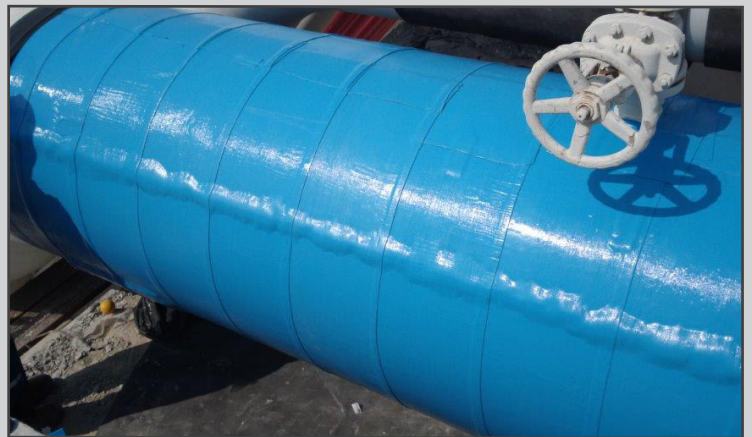
3 Viscotag® Viscowrap Application

Viscotag® Viscowrap HT is applied by removing the release liner and placing adhesive side on the pipe. Initial wrap should be a straight circumference wrap. Once initial straight circumference wrap is completed, wrap with slight tension and a minimum 1/2" overlap.

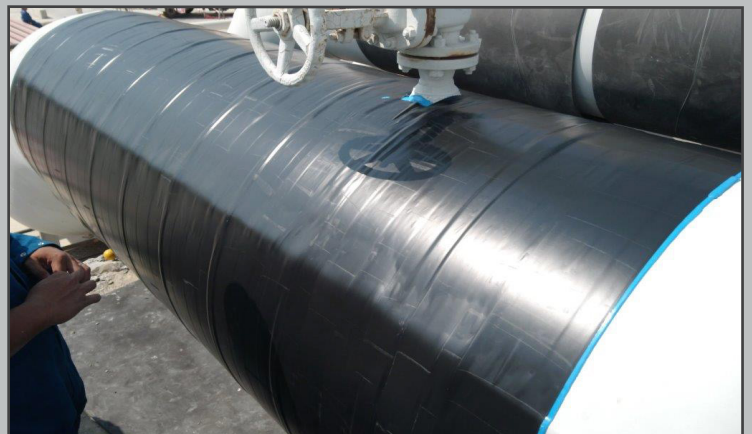
4 Viscotag® PVC Outerwrap Application

Outer Wrap should be wrapped with tension and a minimum of 50 % overlap. First wrap and termination wrap should be a straight circumference wrap

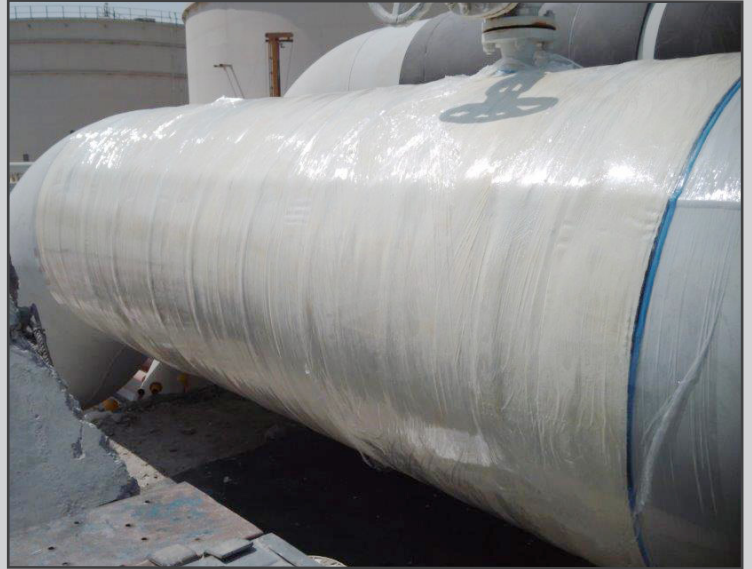
5 Viscotag® PU Composite Wrap Application

As an additional mechanical protection, Viscotag PU polyurethane layer with 66 % overlap over the PVC layer.

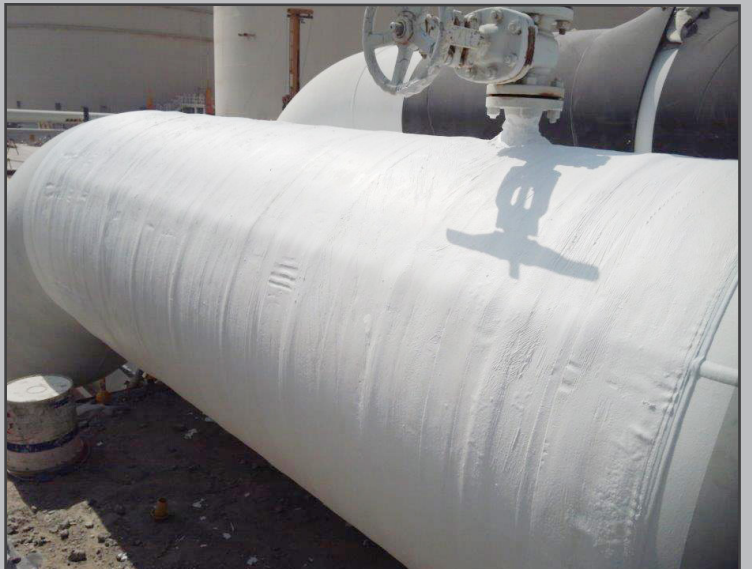
6 UV Resistant Top Coat

The final layer has to be painted with a UV Resistant Top Coat.
