## Case Study

# Viscotag Viscous Elastic Wrapping (Viscopaste, Viscowrap HT, PVC & PU composite wrap) on Soil to Air Riser

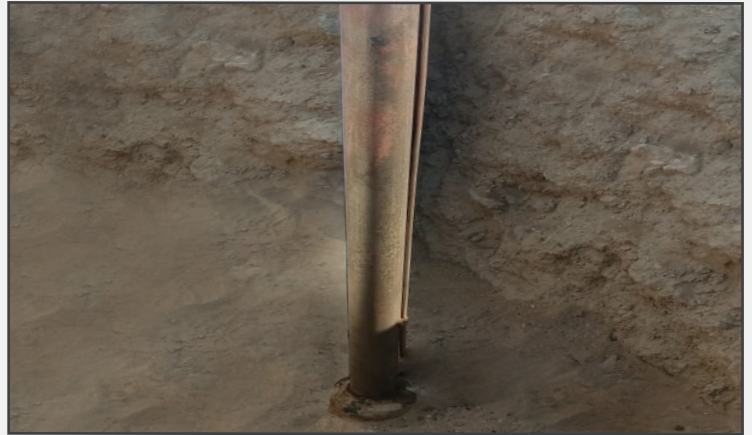
## 1 Surface Preparation

Pipeline suffered severe external corrosion. Surface preparation up to St2

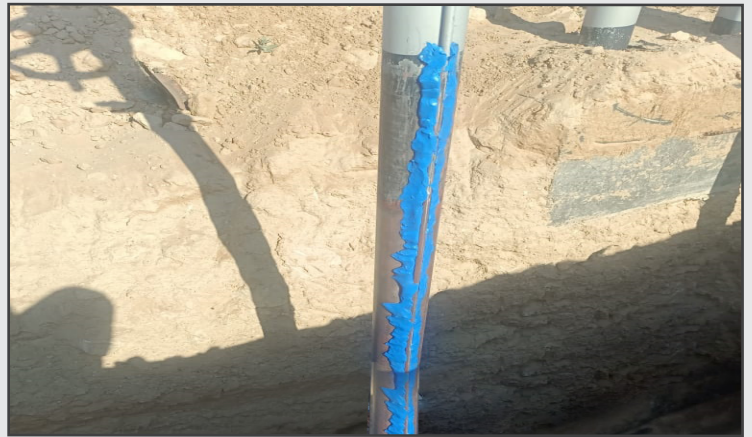
## 2 Viscotag® Viscopaste Application

Apply Viscotag® Viscopaste over the welded area and uneven surface.

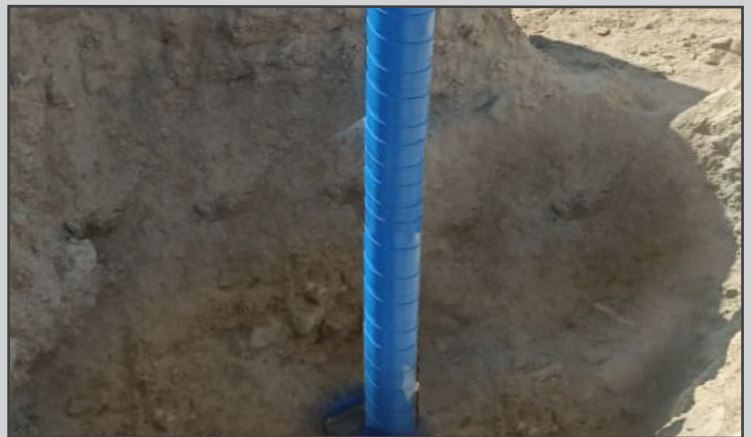
## 3 Viscotag® Viscowrap Application

Viscotag® Viscowrap HT is applied by removing the release liner and placing adhesive side on the pipe. Initial wrap should be a straight circumference wrap. Once initial straight circumference wrap is completed, wrap with slight tension and a minimum 1/2" overlap.

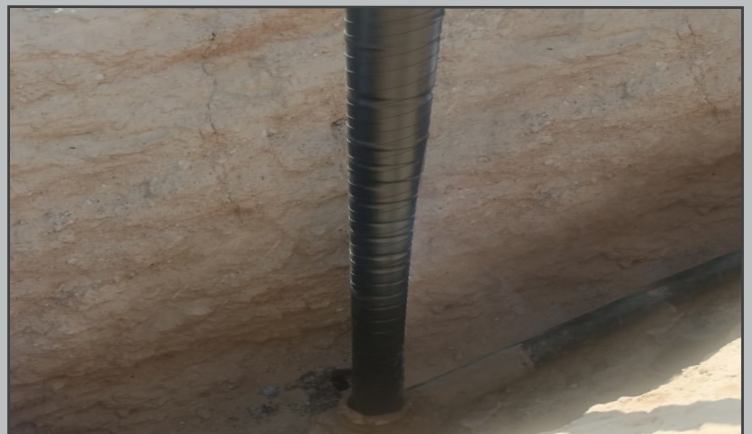
## 4 Viscotag® PVC Outerwrap Application

Outer Wrap should be wrapped with tension and a minimum of 50 % overlap. First wrap and termination wrap should be a straight circumference wrap

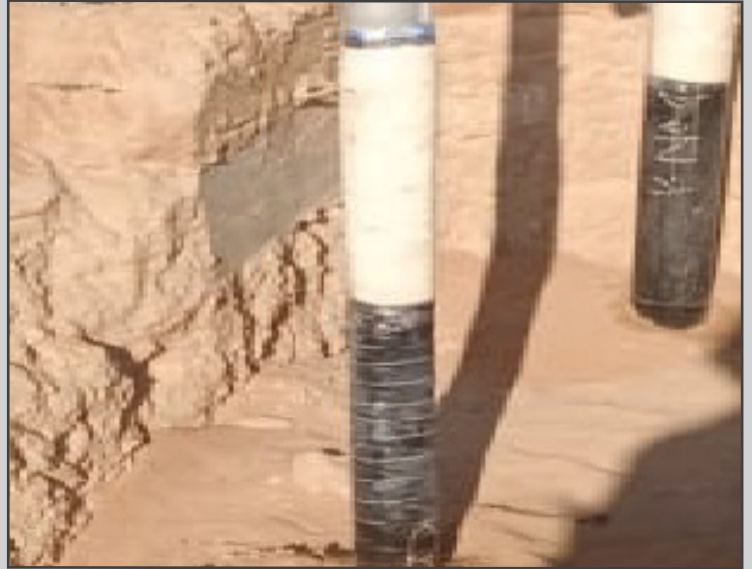
## 5 Viscotag® PU Composite Wrap Application

As an additional mechanical protection, Viscotag PU polyurethane layer with 66 % overlap over the PVC layer.

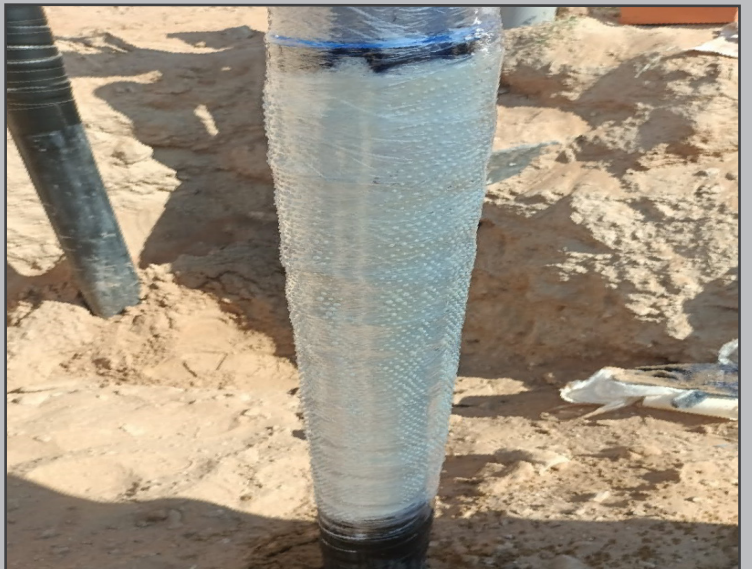
## 6 UV Resistant Top Coat

The final layer has to be painted with a UV Resistant Top Coat.
